GANNETT FLEMING MEMORANDUM

Date: January 27, 2016

Re: Eagle Road Culvert Field View

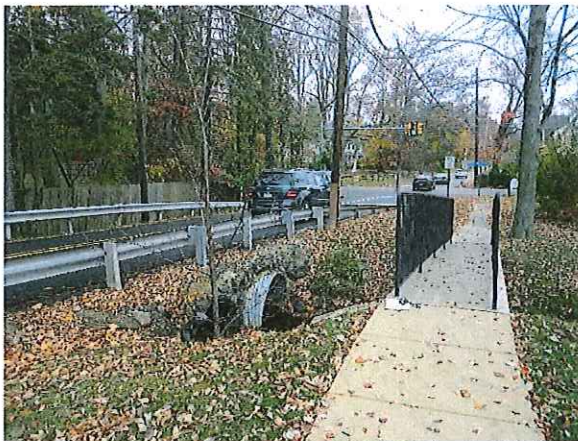
General View of Culvert and Pedestrian Bridge

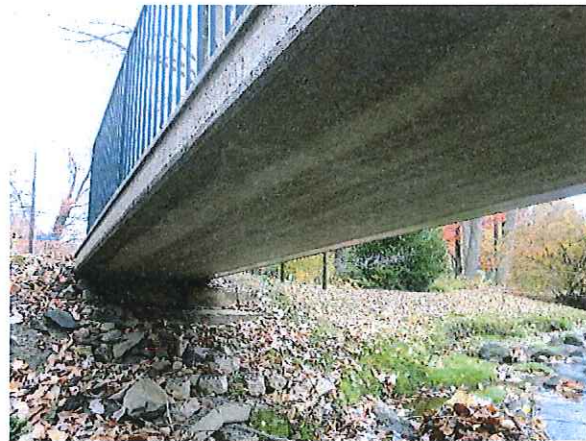
Underdeck View of Pedestrian Bridge

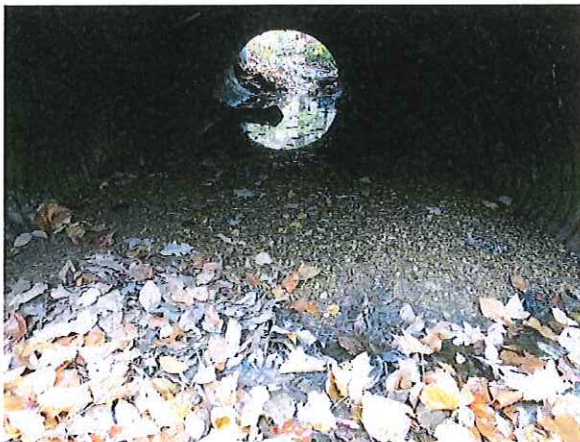
Both steel pipes are heavily corroded with rust laminations throughout. Water flow is diverted to the east pipe only. There is significant silt deposits throughout the west pipe and at the inlet. Water depth in the east pipe at the time of field investigation was approximately 6 inches.

West Pipe with Heavy Silt Built-up

Based on the field assessment and finding, it is recommended to replace the deteriorated corrugated pipes.

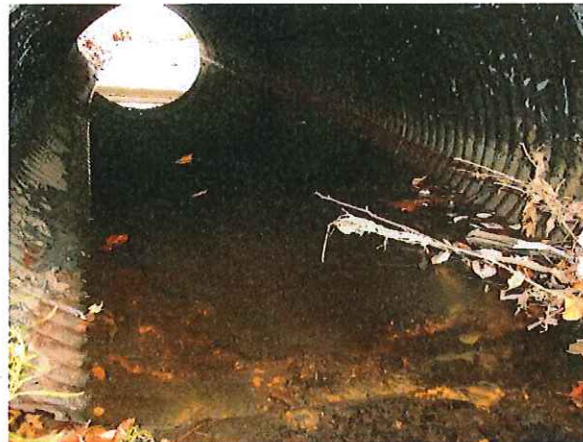
East Pipe with Apparent Heavy Rust

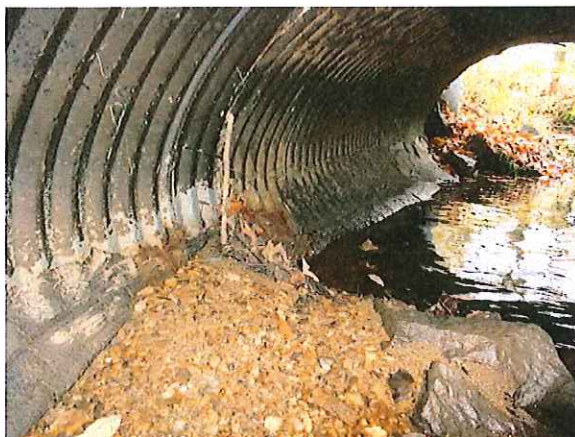
The dual corrugated metal pipes appear to be misaligned at the un-spliced abutting joints and have areas of distortion due to differential movement. The misalignment of the joint in the west pipe has resulted in the loss of fill behind the pipe wall. The crown of the east pipe for a distance of approximately 12 feet from the inlet appears to have excessive deformation. The location of the misalignment and deformation falls within the roadway travel lane.

Misaligned/Distorted West Pipe Shows Loss of Fill Material

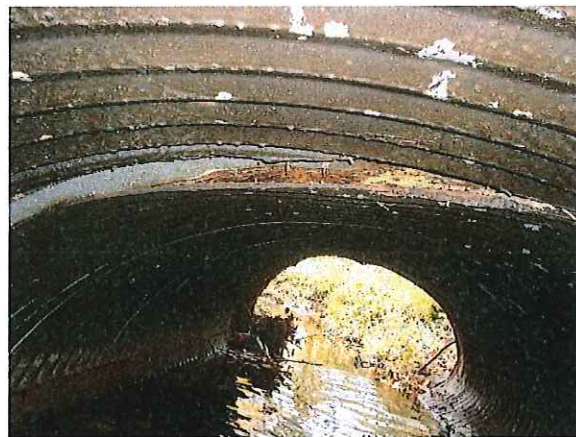
Upstream portion of East Pipe shows Excessive Deformation & Separation from Abutting Section

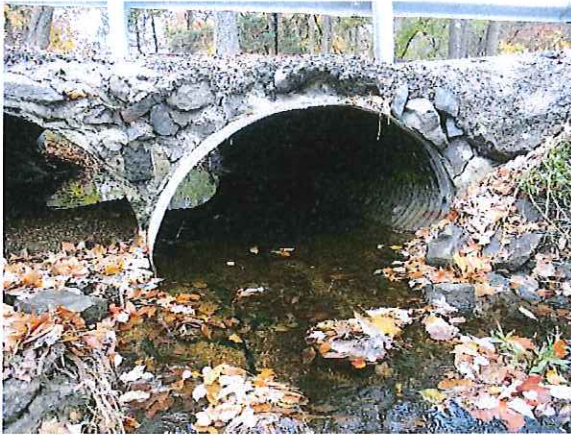
The south headwall is comprised of piled and grouted stones and has a few locations of missing grout joints and is in overall fair condition. The north headwall has areas of voids and loose stones above and between the corrugated pipes.

South Grouted Masonry Headwall

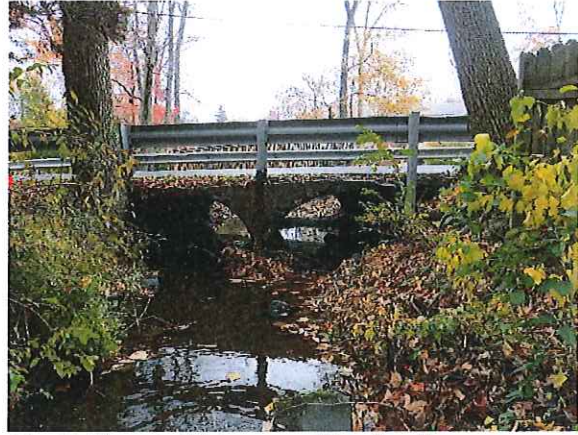
North Grouted Masonry Headwall

- Repack grouted north head wall to avoid continue undermining of pavement material.
- Replace guide rail and posts along north fascia per RC-52M.

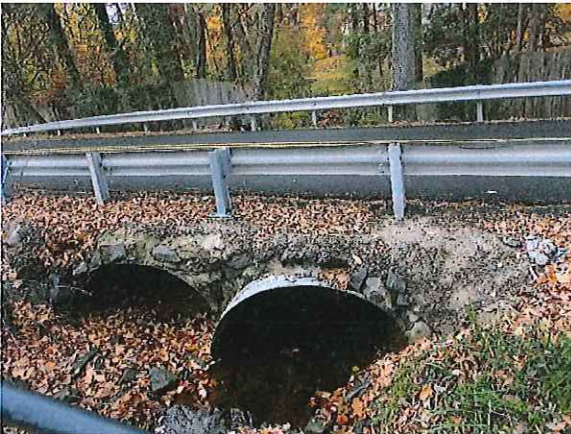
Guiderail extends across the culvert on both sides with railing posts engage each structure headwall. For the south headwall, the three posts are mounted to the headwall with baseplates and anchor bolts, these post and anchor bolt connections are in good condition, however the load carrying capacity of the headwall is questionable. For the north headwall, only the middle post (post #2) engages the headwall. There is severe section loss in posts #1 & #2. Post #1 is supported by a tree, post #2 is cast in the headwall and post #3 is supported from streambed, posts and guiderail are displaced.

Guiderail Posts at South Fascia

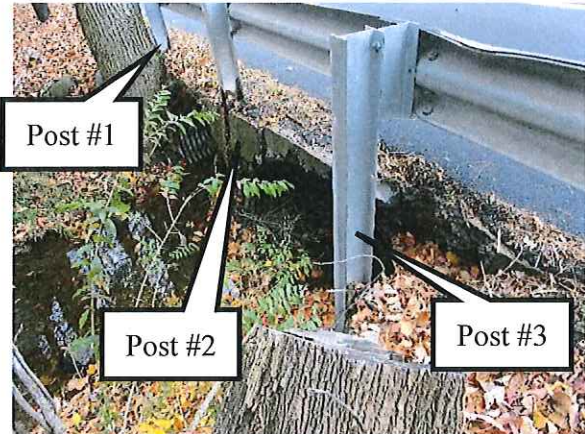
Guiderail Posts at North Fascia

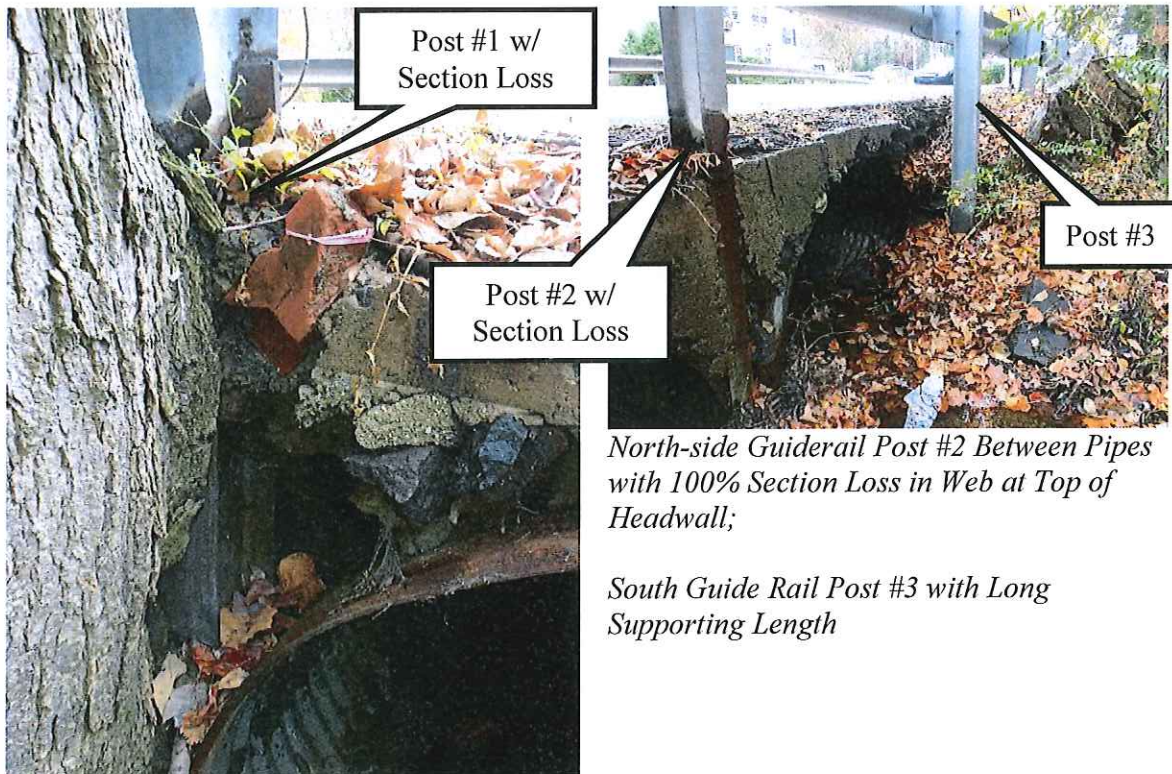
North-side Guiderail Post #1 Behind Tree

North-side Guiderail Post #2 Between Pipes with 100% Section Loss in Web at Top of Headwall;

South Guide Rail Post #3 with Long Supporting Length
