GANNETT FLEMING MEMORANDUM

Date: January 27, 2016

To: Radnor Township

Re: Sawmill Road Arch Bridge Field View

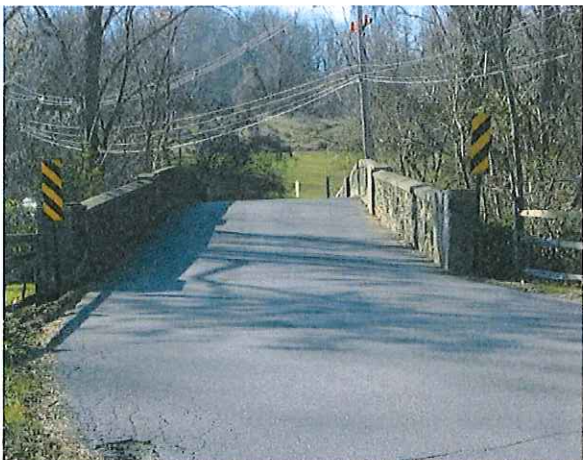
General View of Arch Bridge – Looking East

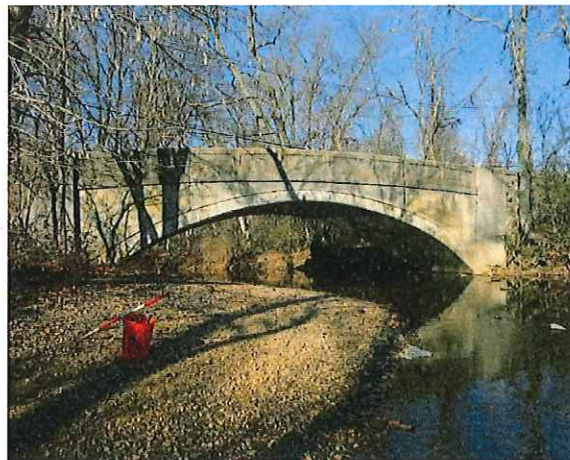
Downstream (South) Elevation

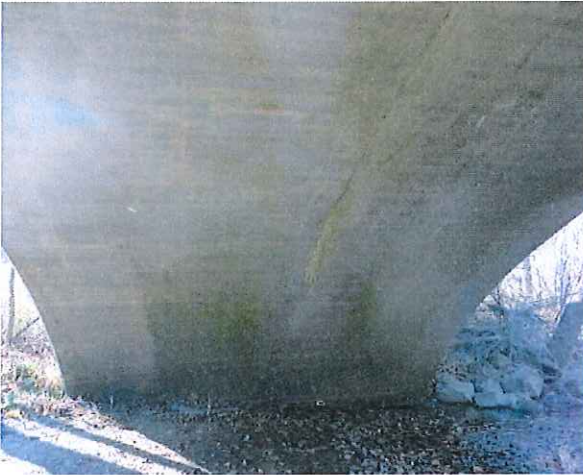
Concrete Arch Barrel – Looking at West Abutment

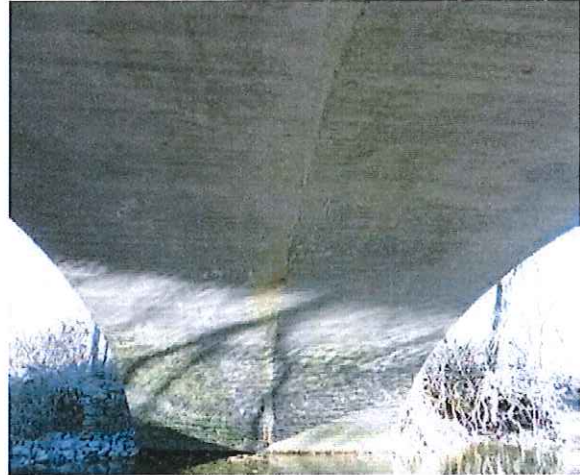
Concrete Arch Barrel – Looking at East Abutment

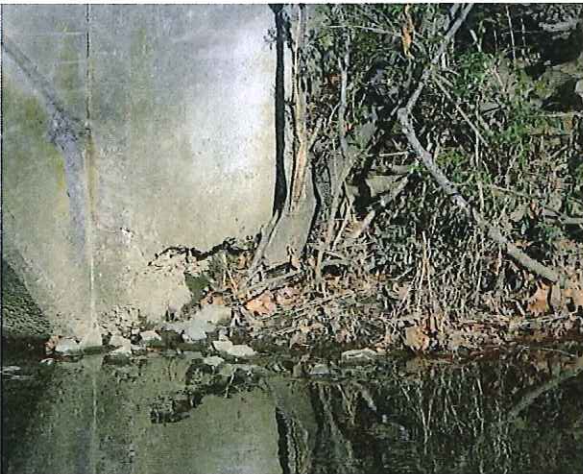
The arch barrel is in good condition with no major defects, except a large spall is noticeable at the bottom of the southeast wingwall, and two small spalls and a few fine map cracks with efflorescence on the southern side of the arch barrel. The arch barriers are in fair condition with small spalls at various locations. All masonry U-shape wingwalls are in good condition.

Large Spall at Bottom of Southeast Wingwall

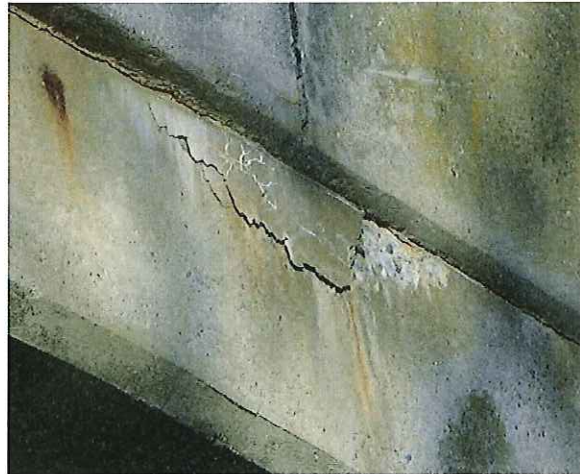
Surface Spall in South Fascia of Arch Barrel

- Repair spalls/cracks in fascia of arch ring.
- Remove trees and provide riprap protection at downstream left bank to prevent further bank erosion.
- Relocate the pedestrian crosswalk to the west, away from the structure, to the intersection with Earles Lane. The trails within the parks could be reconfigured with minimal earth disturbance to affect this change. This will allow vehicles to better observe pedestrians in the crosswalk and will allow pedestrians to see oncoming traffic from the bridge.
- Provide painted yield bars on the roadway at both bridge approaches with adjacent signing "YIELD TO ONCOMING TRAFFIC". This will allow vehicles on either approach to yield to a vehicle already on the structure.
- Provide guide rail or crash worthy end treatments on all four corners of the structure.

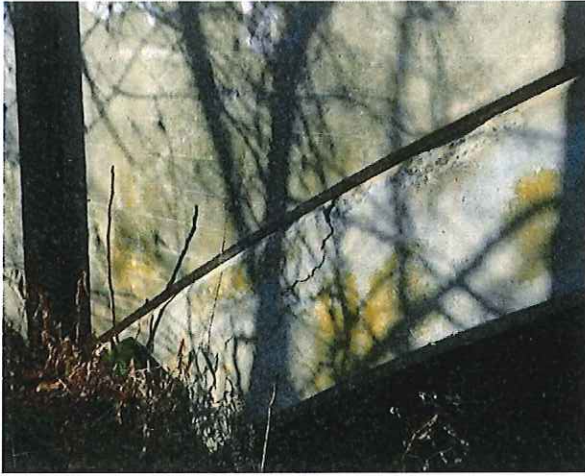
Surface Spall in South Fascia of Arch Barrel

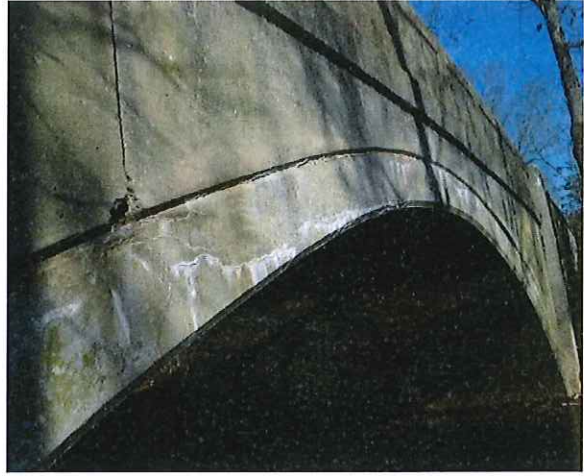
Small Spall in South Spandrel Wall and Fine Map Cracks with Efflorescence in South Fascia of Arch Barrel

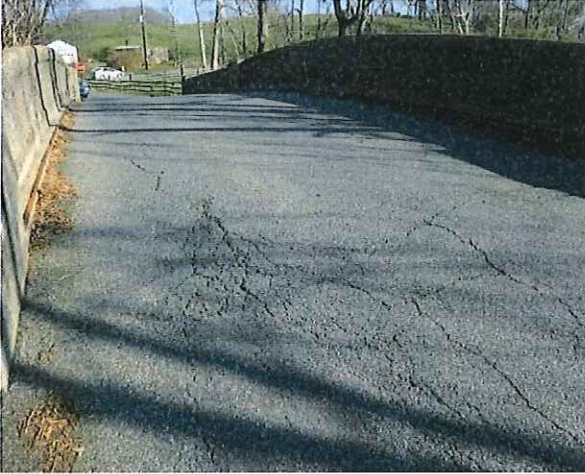
View of Pavement – Cracks throughout

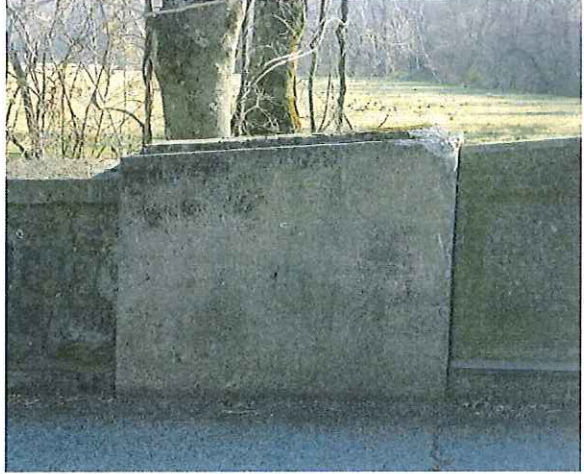
Spalls in Bridge Barrier

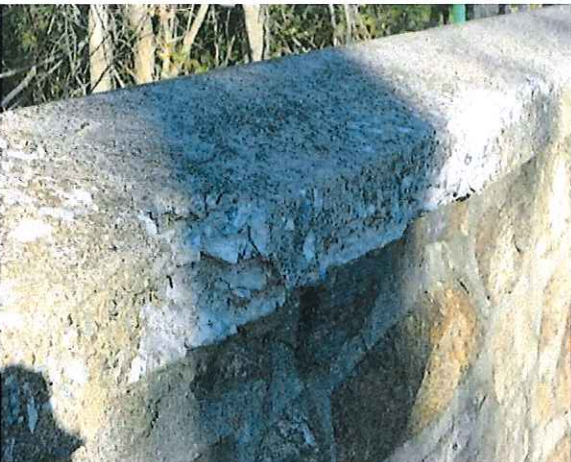
Spalls in Concrete Cap of Wingwall Barrier

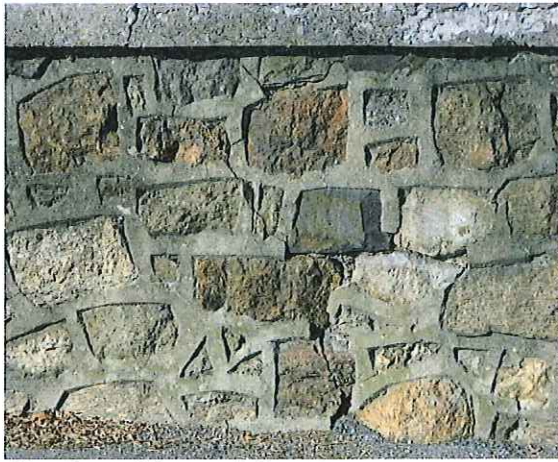
Cracks in Wingwall Barrier

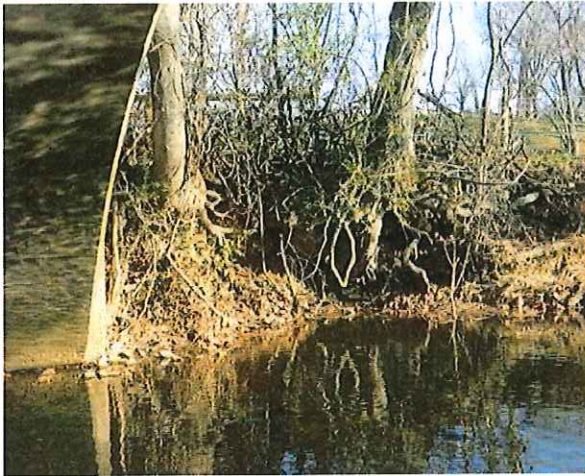
There is severe bank erosion with exposed tree roots at southeast corner of the bridge.

Bank Erosion with Exposed Tree Roots in Bank of Southeast Corner of the Bridge

There is a large sediment deposit under the arch blocking half the waterway channel. Water flows along the east abutment and causes severe bank erosion.

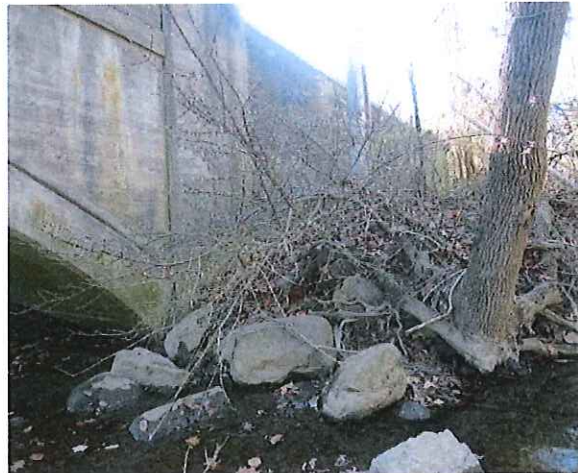
Upstream Right Bank at West Abutment

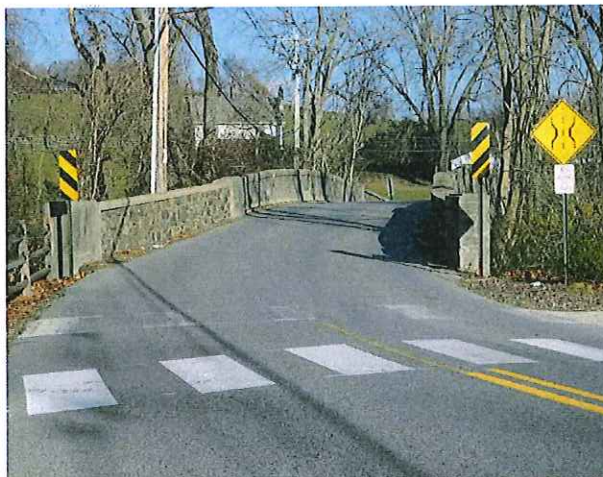
West Approach, Note Pedestrian Cross Walk was Previously Relocated Once

A pedestrian cross walk is located on the west approach between Skunk Hollow Park and Saw Mill Park. Pedestrians in the crosswalk do not have a clear view to the east over the structure.

Sight distance across the structure is also restrictive due to the vertical curve on the structure and a horizontal curve on the west approach to the bridge, there is no speed limit posting on either approach of the bridge. This creates a situation where pedestrian in the crosswalk and vehicles approaching the structure at the same time from opposite directions have difficulty seeing each other.

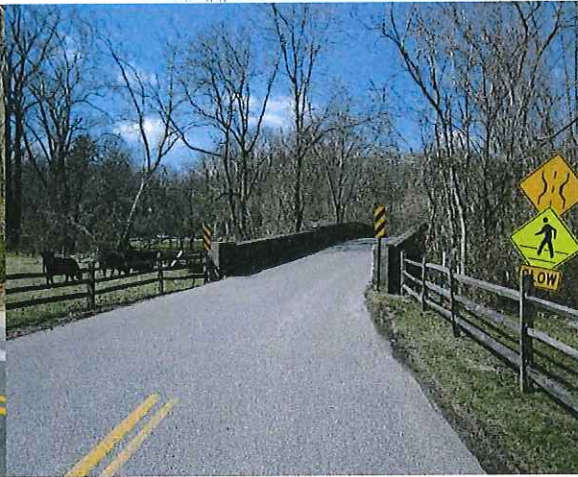
East Approach, Note Sign of Pedestrian Crossing
