GANNETT FLEMING MEMORANDUM

Date: January 27, 2016

Re: South Devon Avenue Culvert Field View

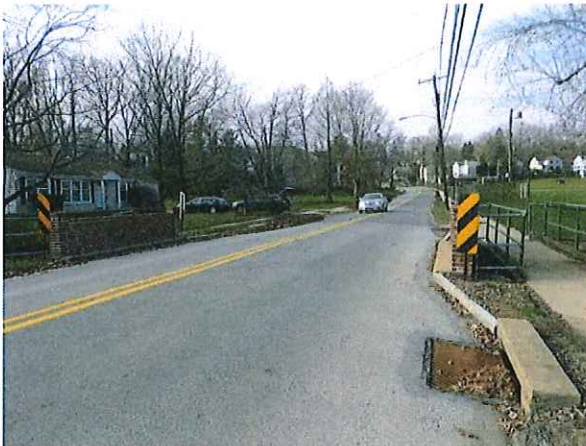
*General View of Roadway and Pedestrian Bridges
Looking West*

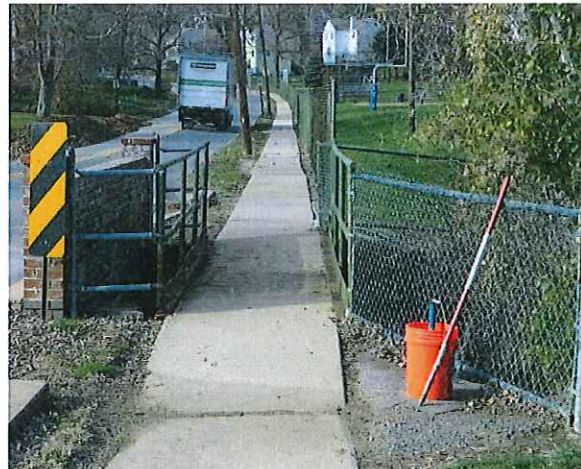
North Pedestrian Bridge (South Pedestrian similar)

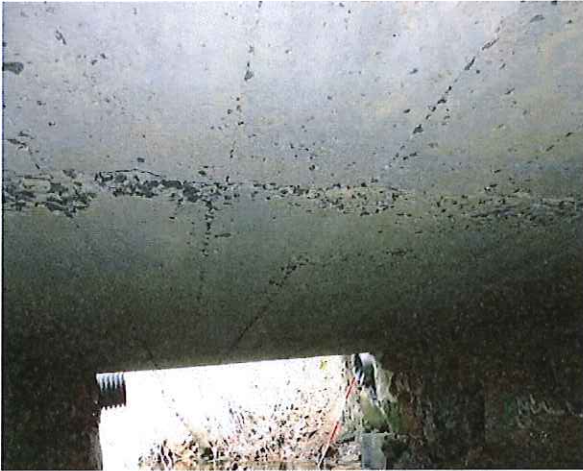
The concrete slab superstructure of the main structure is in good condition with localized honeycombing and exposed aggregate. No spalls or exposed reinforcing steel is noted.

Under Deck View (H.C. in middle width)

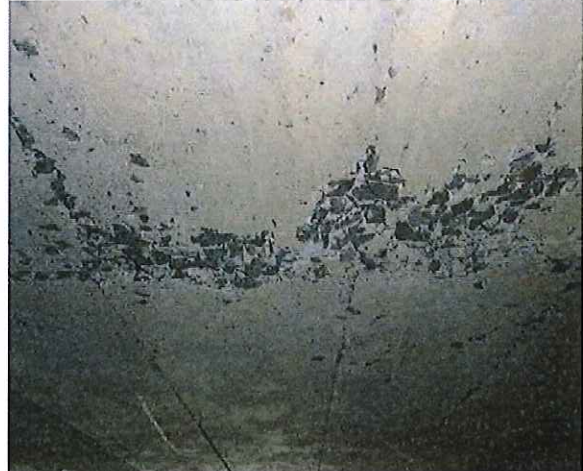
Honeycombing and Exposed Aggregate

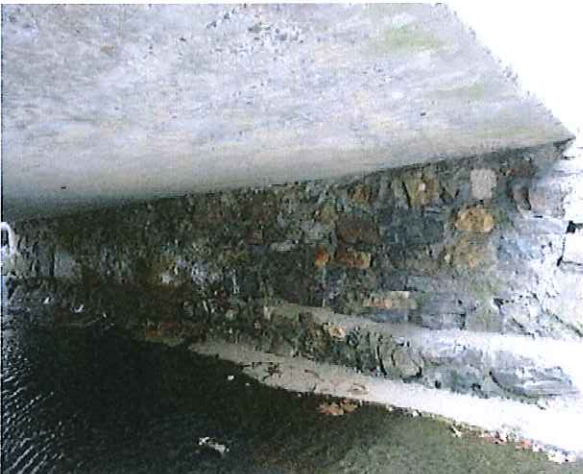
Both abutments and wingwalls are stone masonry, all are in good condition except for Wing A and Wing D.

Typical Masonry Abutment

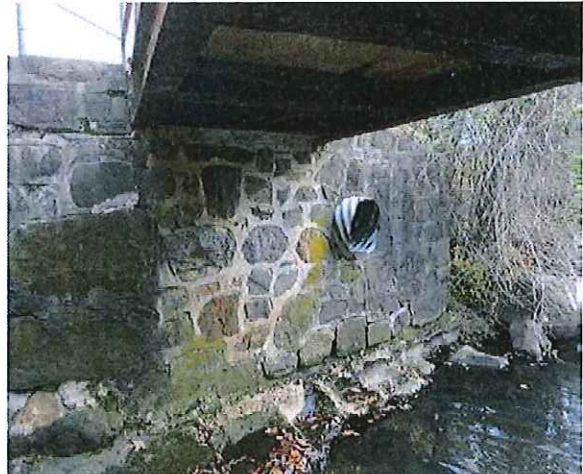
Wing B (Wing C similar)

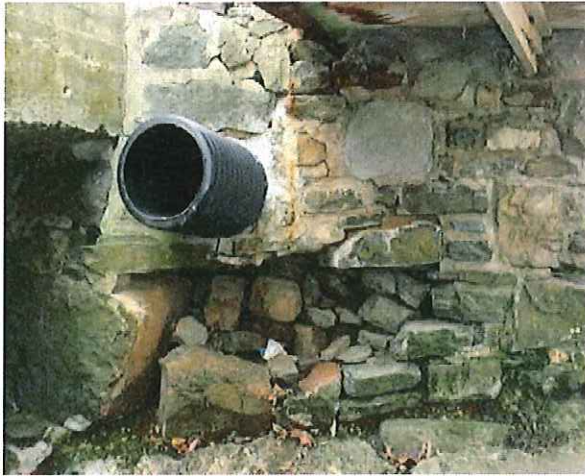
At Wing D, stones are missing from below the 12" diameter drainage pipe with more than 12" undermining; Wing A exhibits missing stone, missing mortar joints and water leakage at the groundline.

Missing Stones and Undermining in Wing D

The Superstructure of the north pedestrian bridge and Wing D are in poor condition. Wing A is in fair condition.

The existing bridge and south pedestrian bridge will be rehabilitated and therefore no Geotechnical Investigation is necessary. However, the replacement of the deteriorated superstructure of North Pedestrian Bridge and rebuild of Wings A & D that supports the pedestrian bridge is recommended.

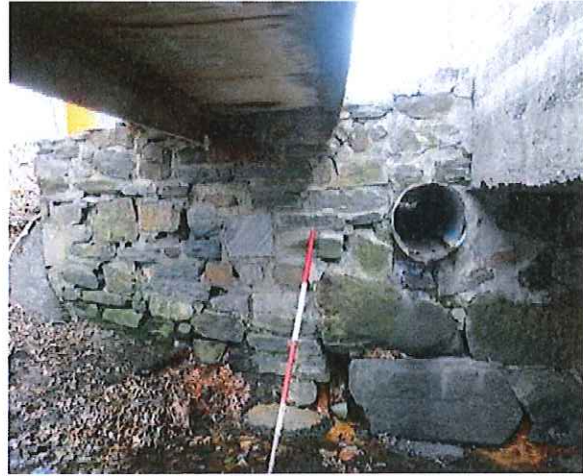
Missing Stones and Mortar Joints in Wing A

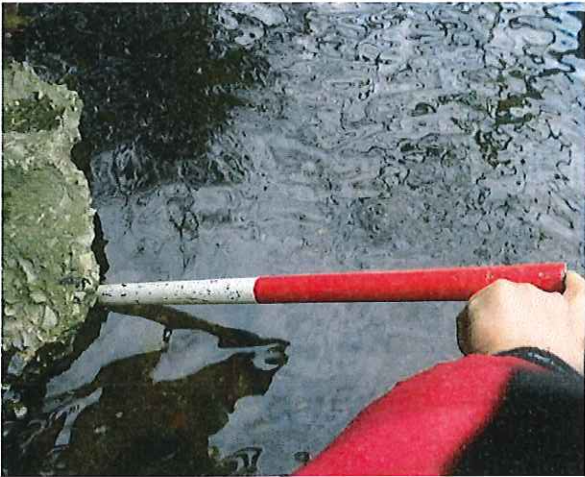
Note that concrete aprons of varying width are present at both Wing B and Wing C (downstream wings). It is assumed that the aprons serve the purpose of splash block for ground water flows into the creek through drainage pipes. Both aprons are undermined up to 2'-0". Streambed under the bridge is paved with concrete and in good condition; water flow over the streambed is approximately 1" deep. A waterfall is formed at end of the paved streambed and a 2'-3" deep scour hole beyond the paved streambed between Wing B and Wing C is noticeable. There is no noticeable bank erosion.

2' Undermining under Wing B Apron

Both downstream wingwalls (Wing B and Wing C) that support the south pedestrian bridge are in fair condition with a few missing mortar joints and undermining of concrete aprons. The Superstructure of the south pedestrian bridge is in fair condition with heavy rust in stringers and floor beams.

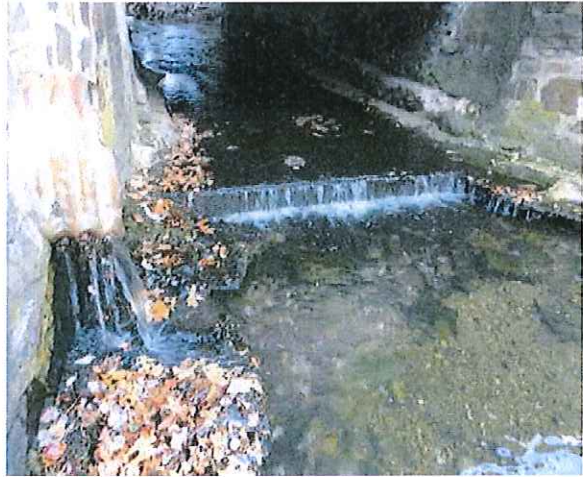
Large Scour Hole at end of Culvert

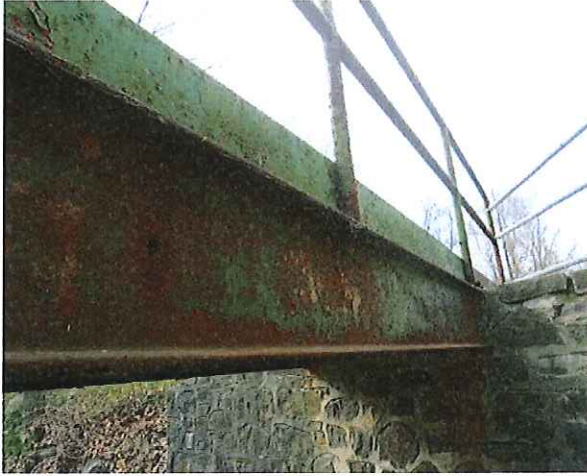
The south pedestrian bridge features two (2) W12 stringers with five (5) W5 floor beams and a pressure-treated plywood stay-in-place form. Both stringers and floor beams exhibit heavy rust and delamination with minor section loss throughout; the plywood form is in fair condition.

South Pedestrian Bridge Elevation View

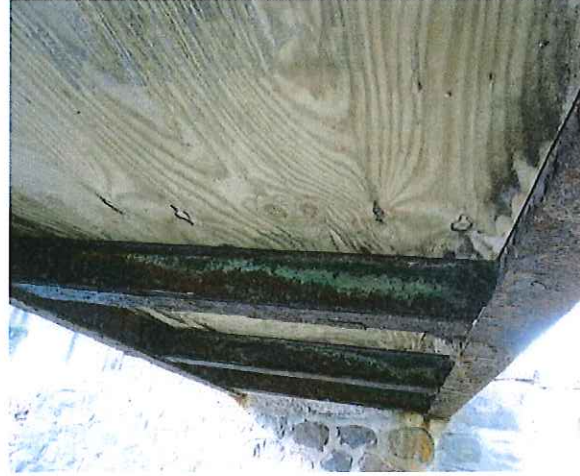
South Pedestrian Bridge Underdeck View

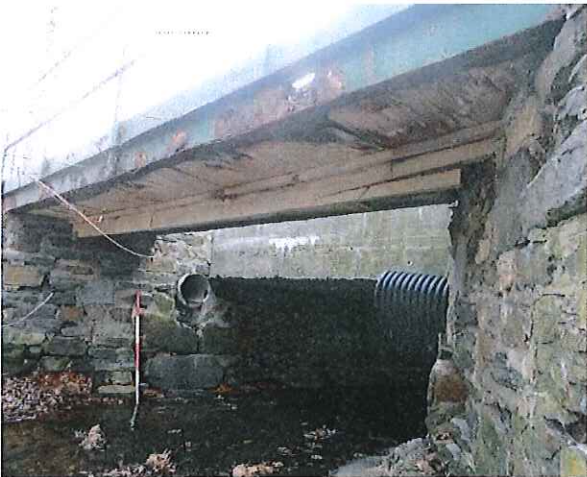
The north pedestrian bridge is composed of two (2) W8 stringers, concrete deck and plywood form, and is also supported by a built-up auxiliary timber T-beam (2x6 flange and stem). The W8 stringers are heavily rusted with 100% loss of webs and more than 50% loss of bottom flanges and are losing their carrying capacities. A large hole is noticeable in the concrete deck and plywood form. The stem of the built-up timber T-beam splits at middle depth from the end notch.

North Pedestrian Bridge Elevation View

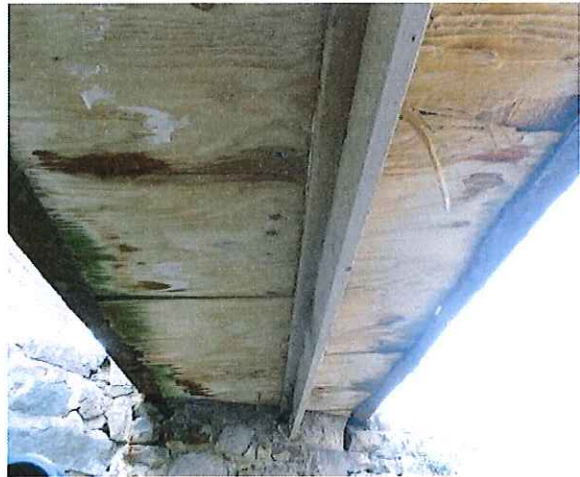
North Pedestrian Bridge Underdeck View

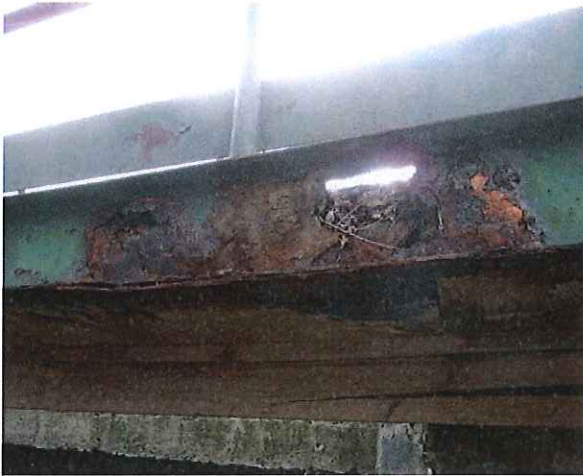
100% Loss in Web of North Stringer

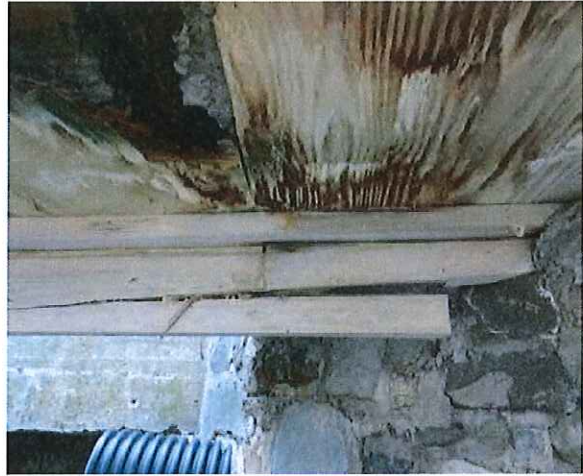
Large Hole in Deck and Horizontal Split in Stem of T-Beam

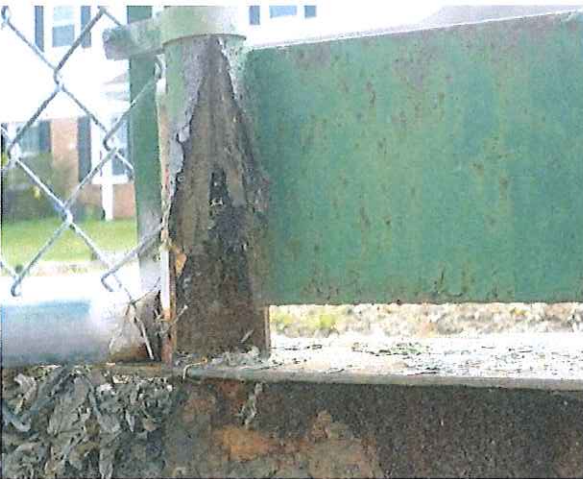
Railing posts for the north pedestrian bridge are either broken or rusted with total section loss. Railing and posts for the south pedestrian bridge are in fair condition.

Section Loss in N. Railing Post of North Pedestrian Bridge

Two of five railing posts of the north pedestrian bridge are ineffective due to either excessive damage or 100% section loss at the base. The rest of the railing posts are in fair condition with heavy rust at the base.

The pedestrian bridges railings are a hazard and should be replaced with the PennDOT Standard Aluminum Pedestrian Railing in BC-716M or approved equivalent.

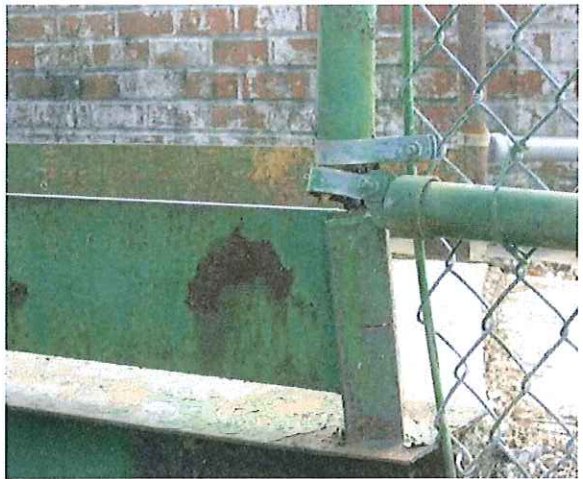
Broken Railing Post in N. Railing of North Pedestrian Bridge
