ROCKWELL ASSOCIATES

Radnor Parks

Re: Level One Park Review

File#: 8373RP

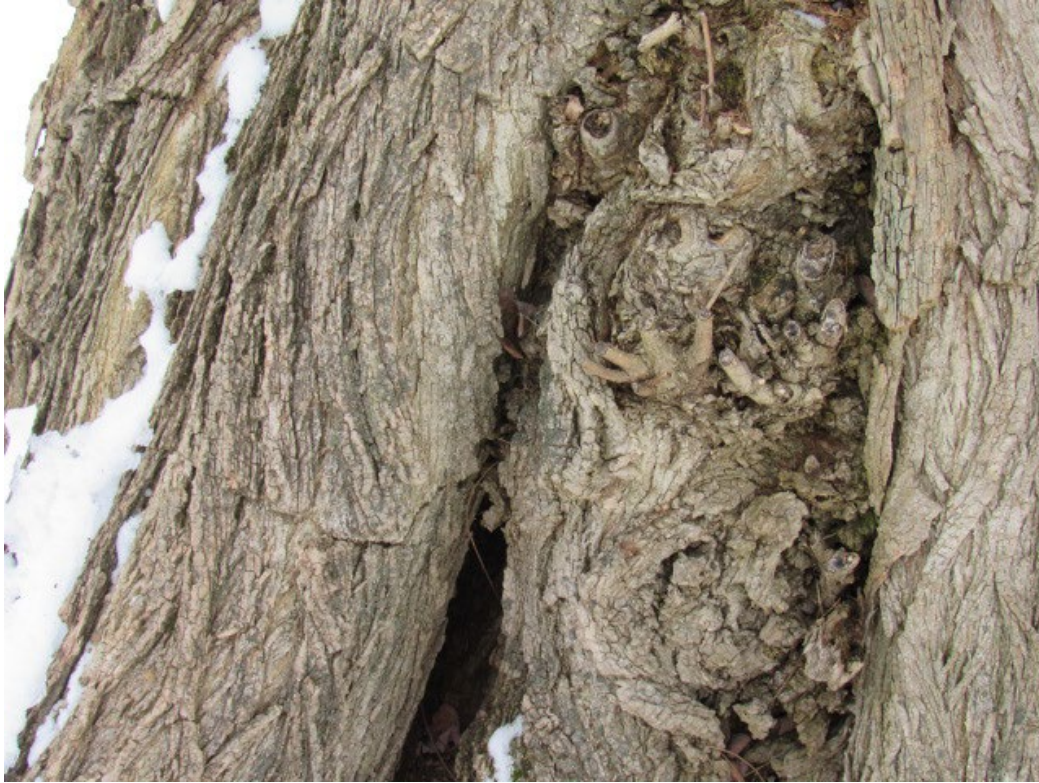
Photo 1, Black Locust showing multiple defects and decay at root flare. Removal recommended.

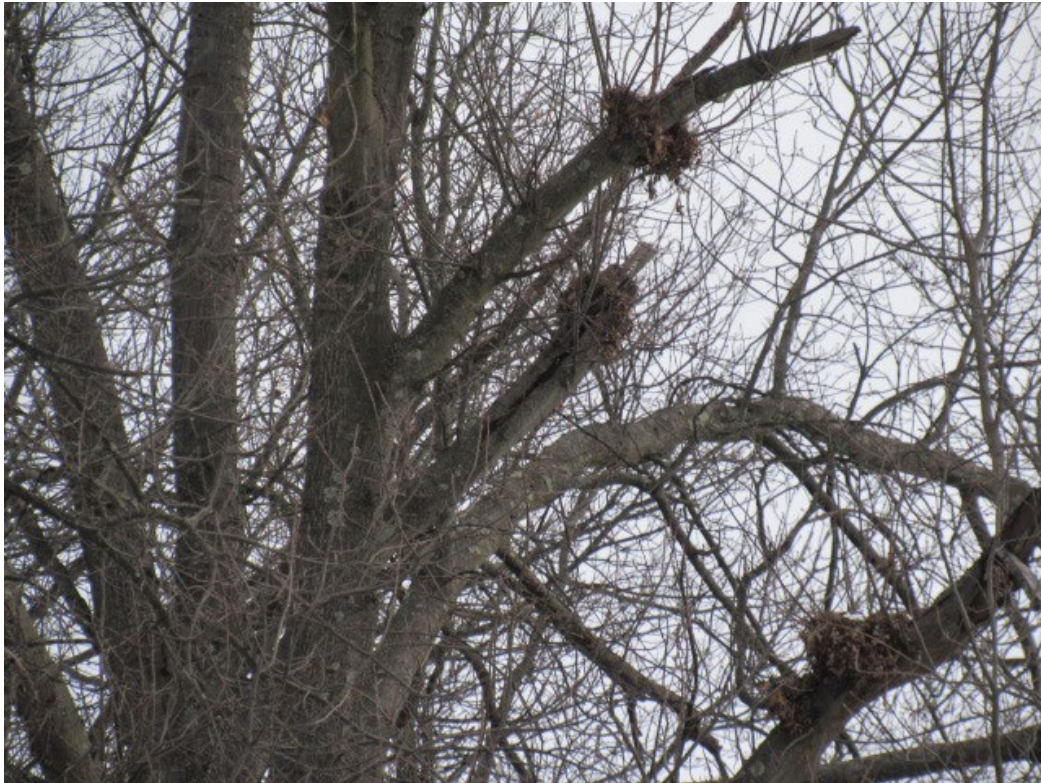
Photo 2, Red Maple showing large broken branches. Pruning recommended.

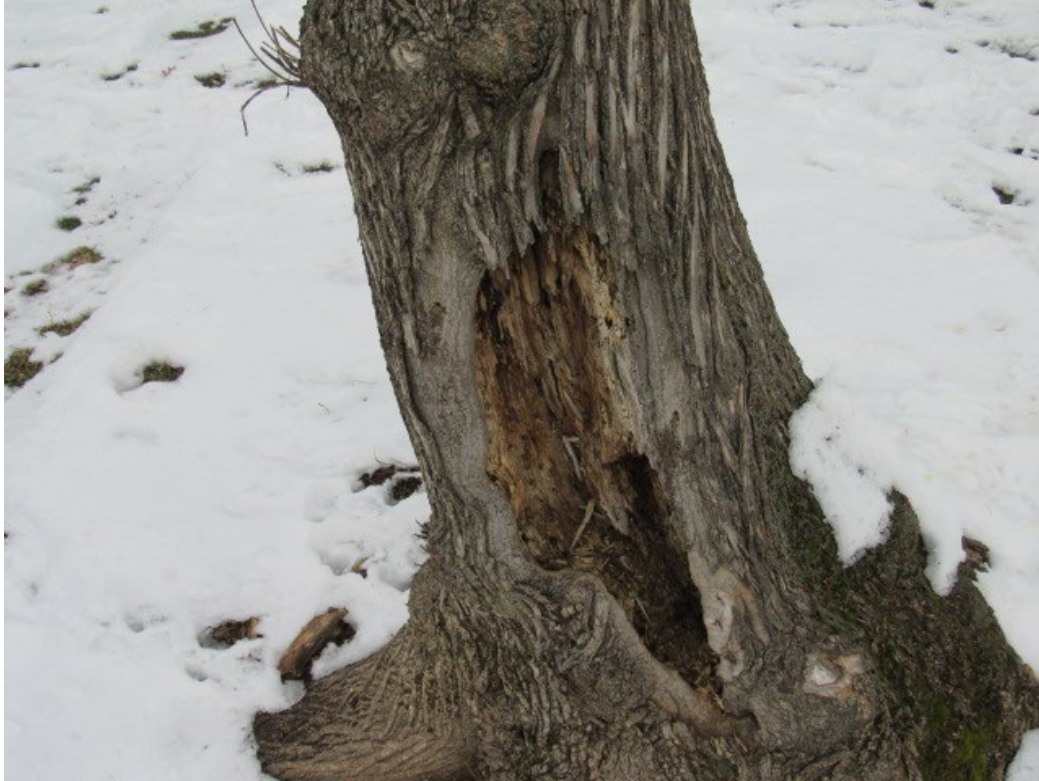
Photo 3, Norway Maple with basal decay. Removal recommended.

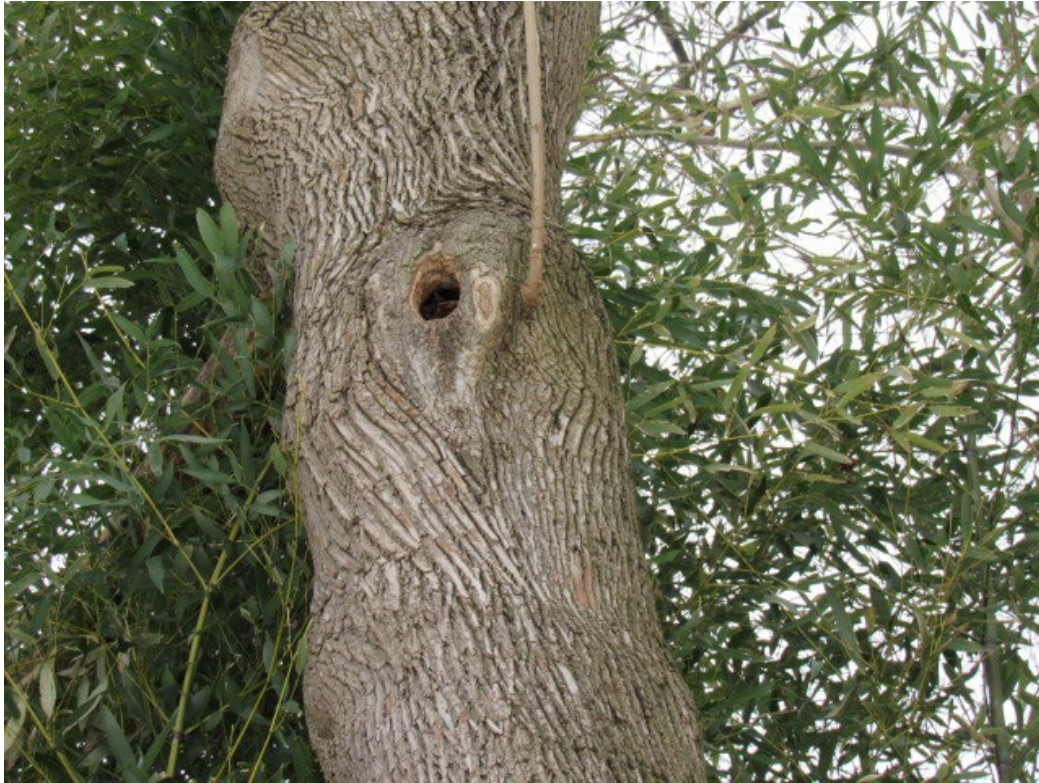
Photo 4, Norway maple with large squirrel hole, hidden decay. Removal recommended.

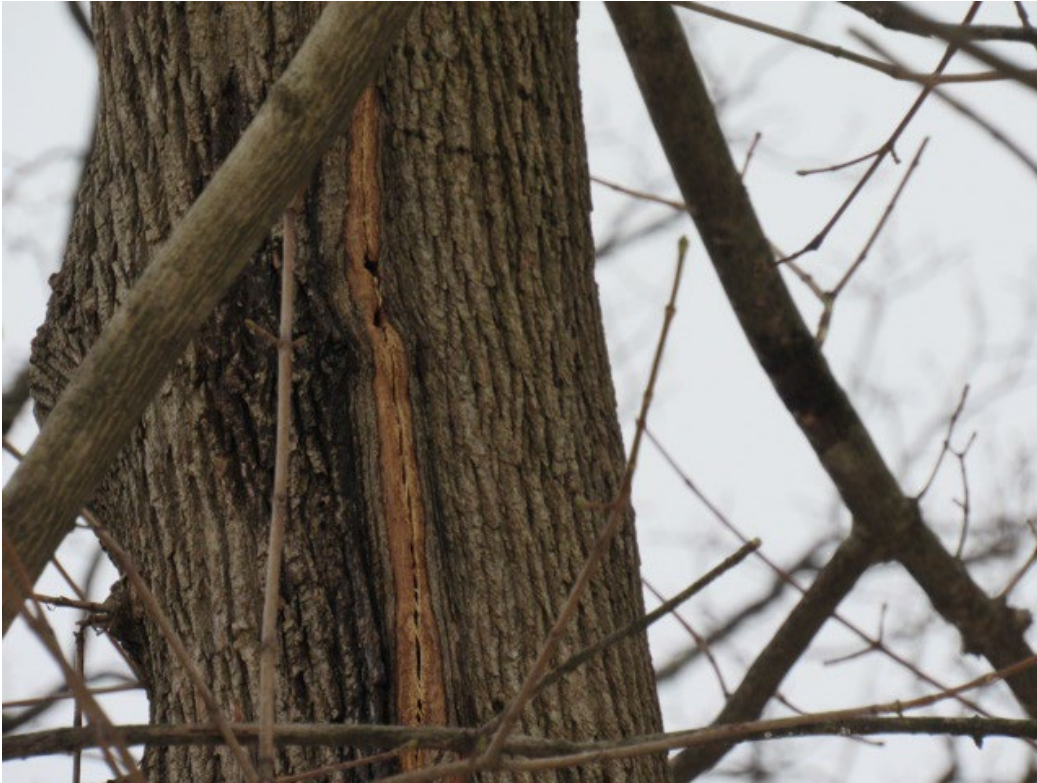
Photo 5, Norway Maple with split/ seam. Removal recommended.

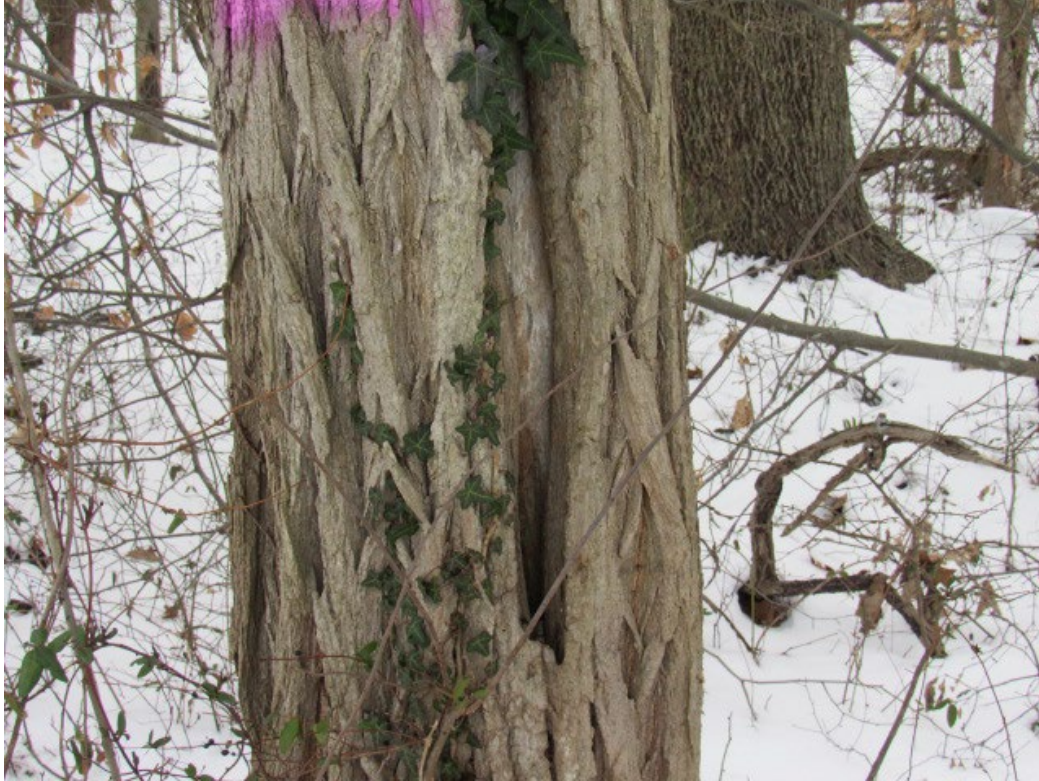
Photo 6, Black Locust with stem decay. Removal recommended.

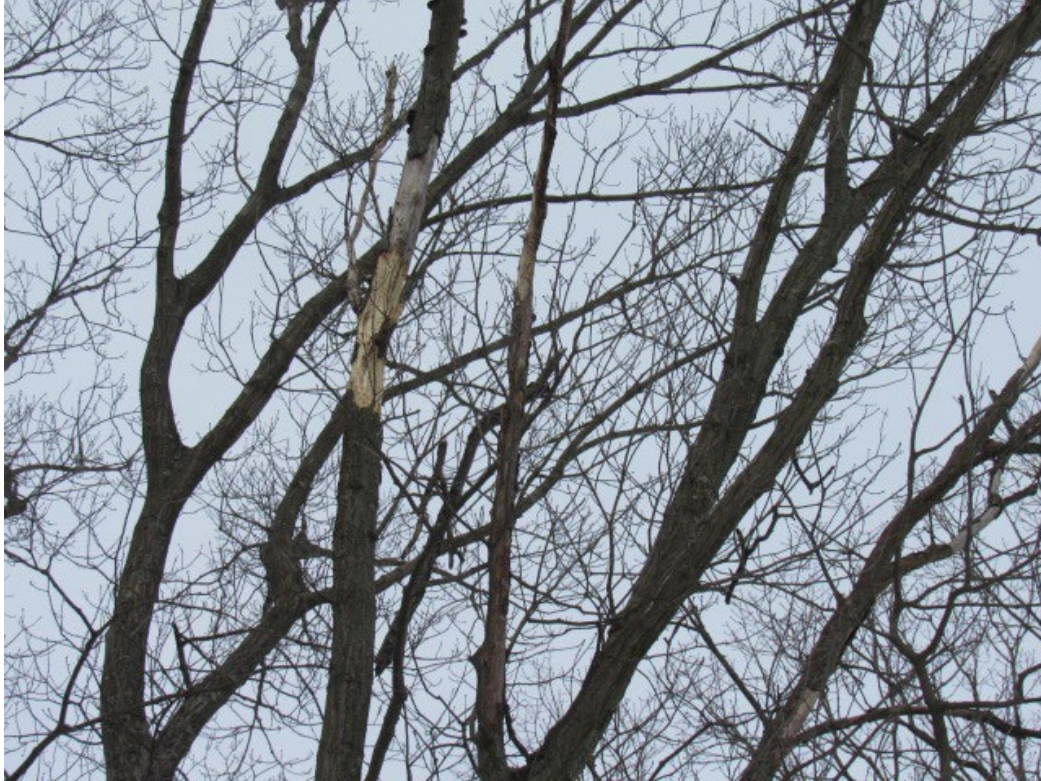
Photo 7, Mature Oak with massive dead branches. Pruning recommended.

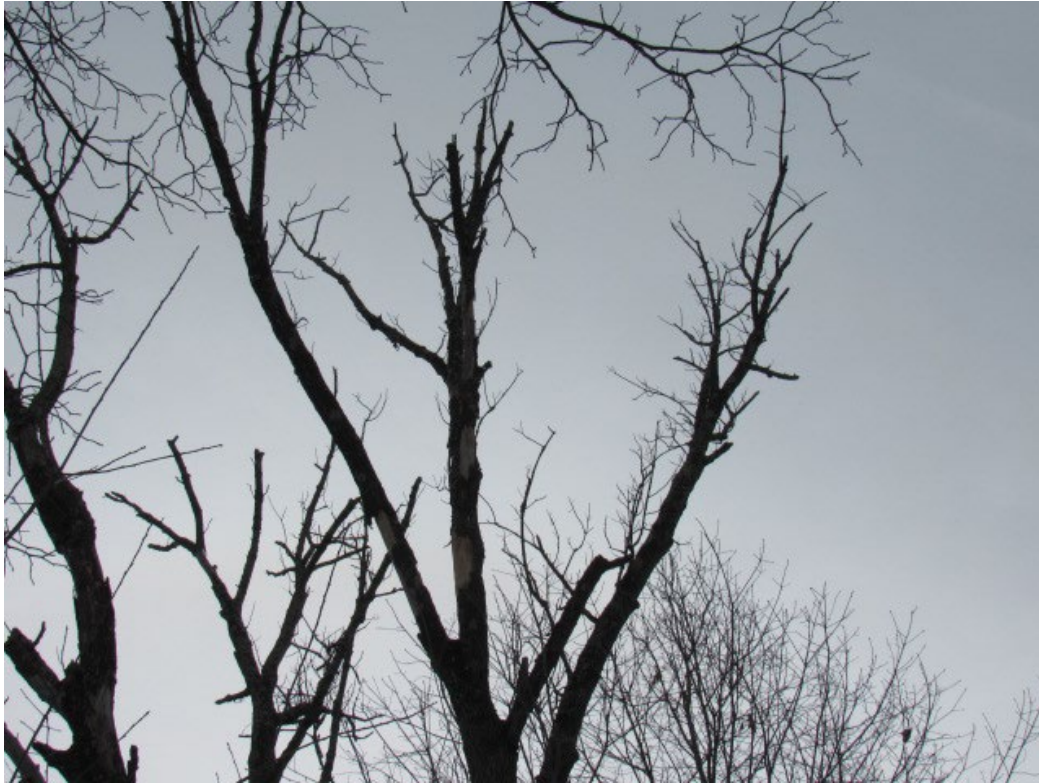
Photo 8, Top of dead Ash, Killed by Emerald Ash Borers. Removal recommended.

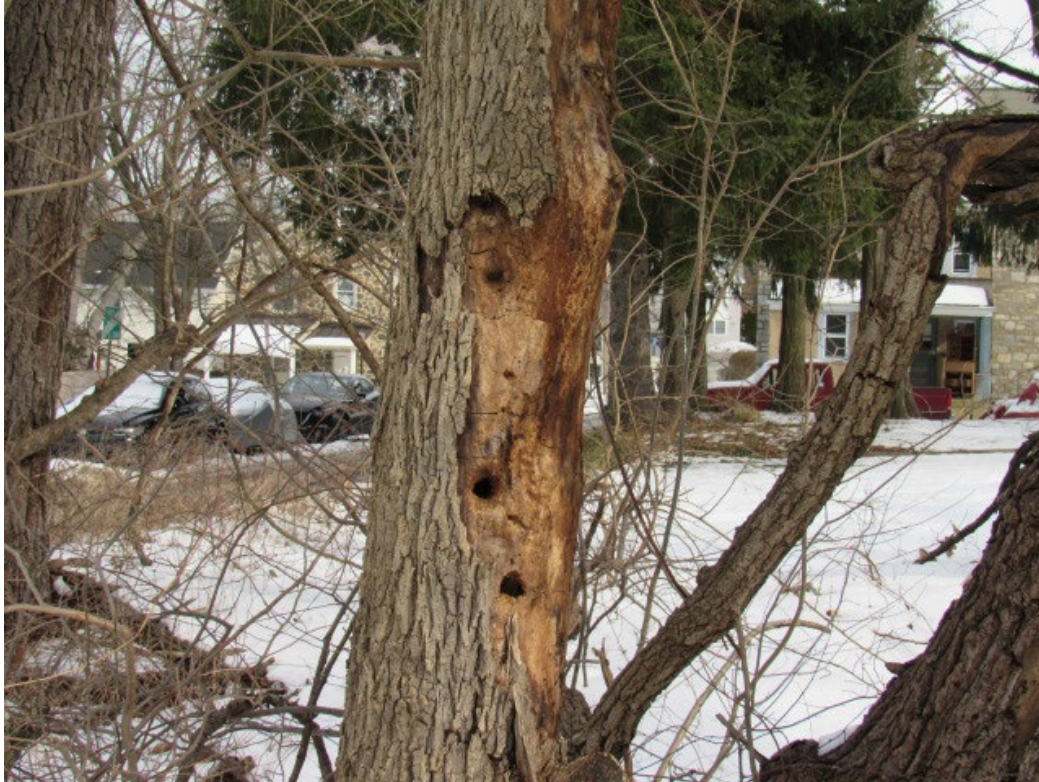
Photo 9, Dead Ash with stem deterioration. Removal recommended.

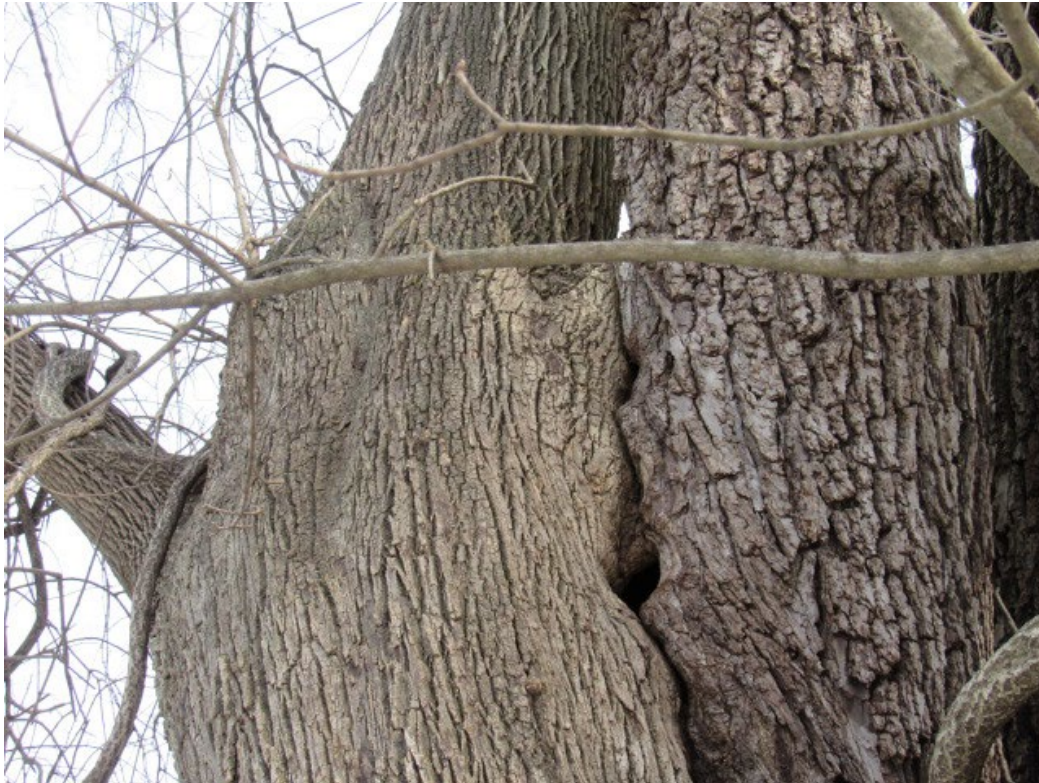
Photo 10, Ash and Walnut fused at stems with hidden decay in both trees. Both trees are recommended for removal.

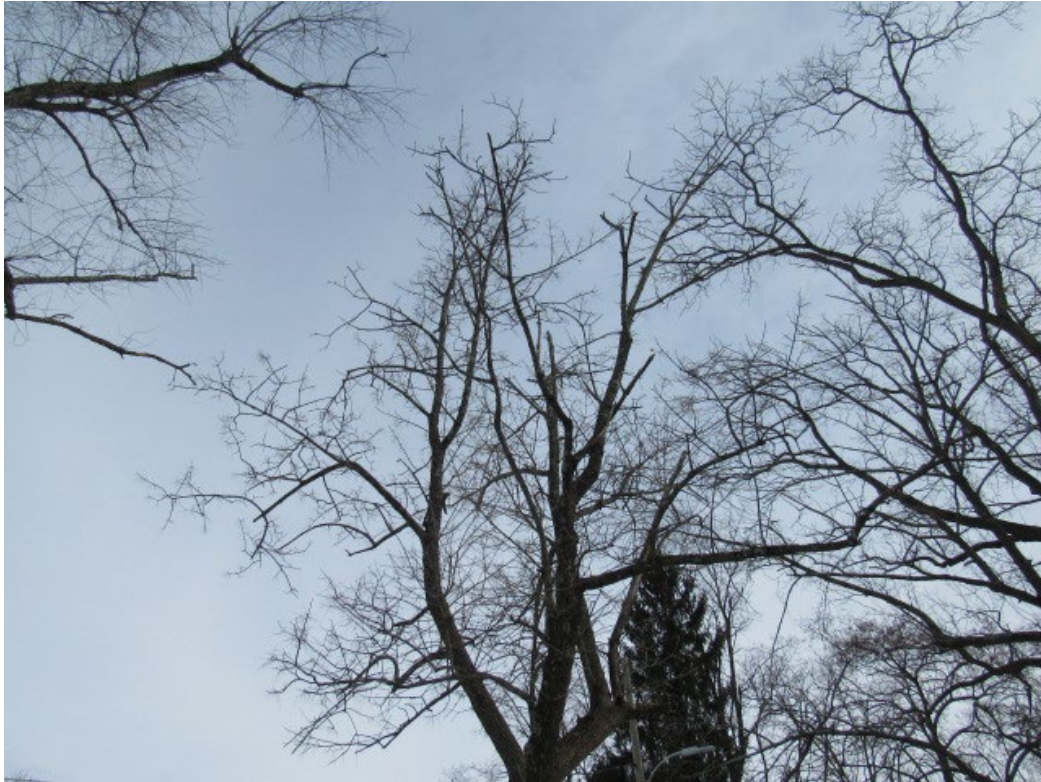
Photo 11, Crown of declining Ash infested with Emerald Ash Borers. Removal recommended.

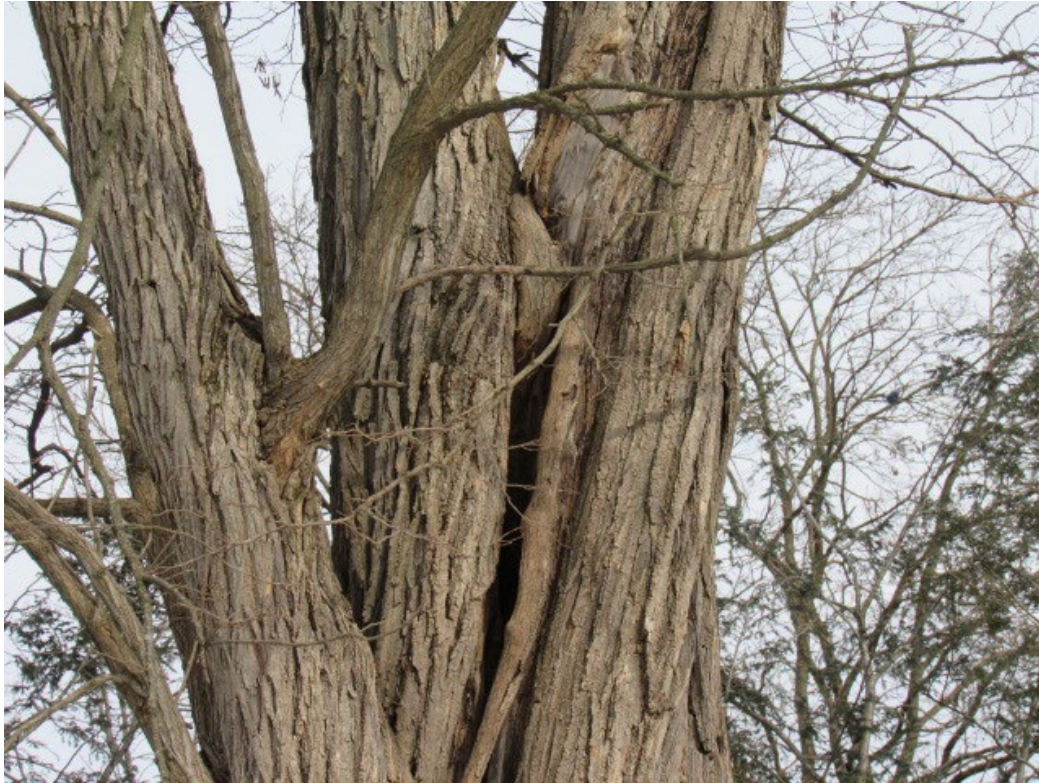
Photo 12, upper stem of Black Locust showing stem decay. Removal recommended.

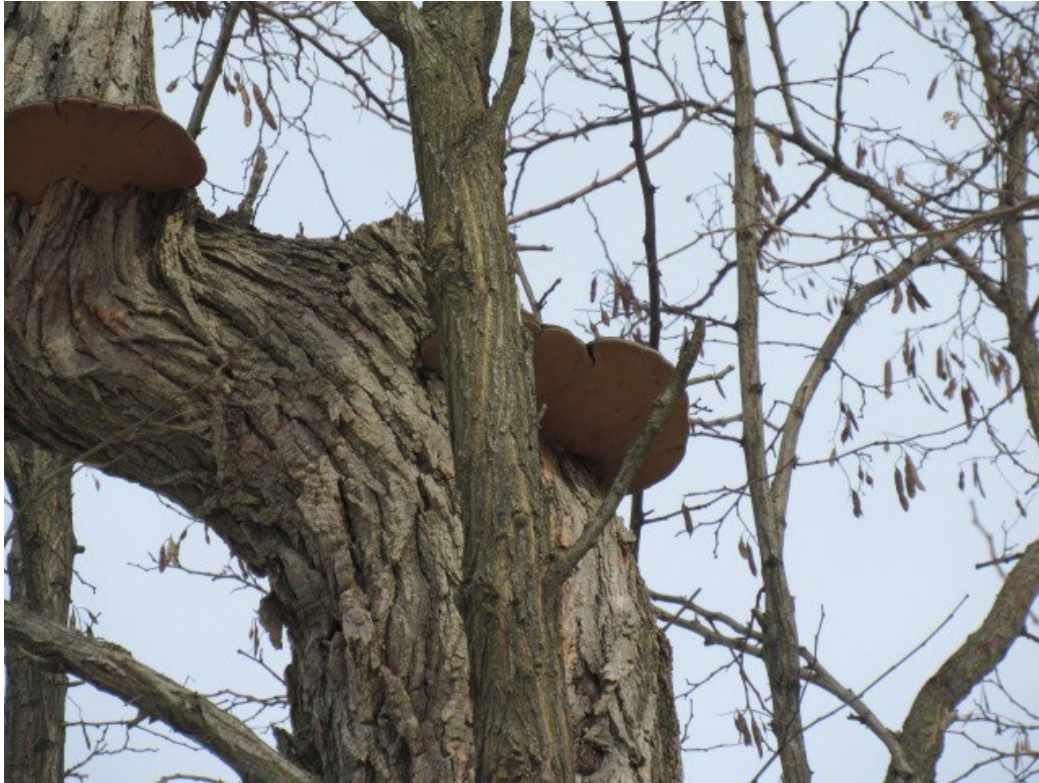
Photo 13, Upper-stem of Black Locust showing crook with bracket fungi. Removal recommended.

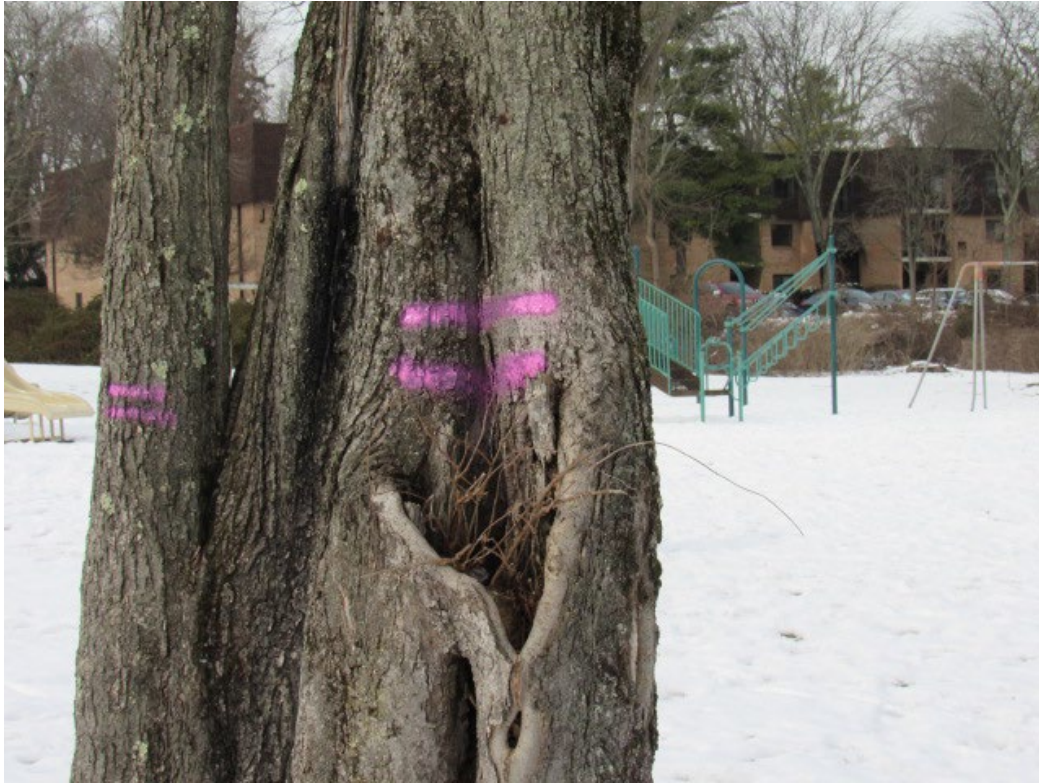
Photo 14, Red Maple with lower stem decay. Removal recommended.

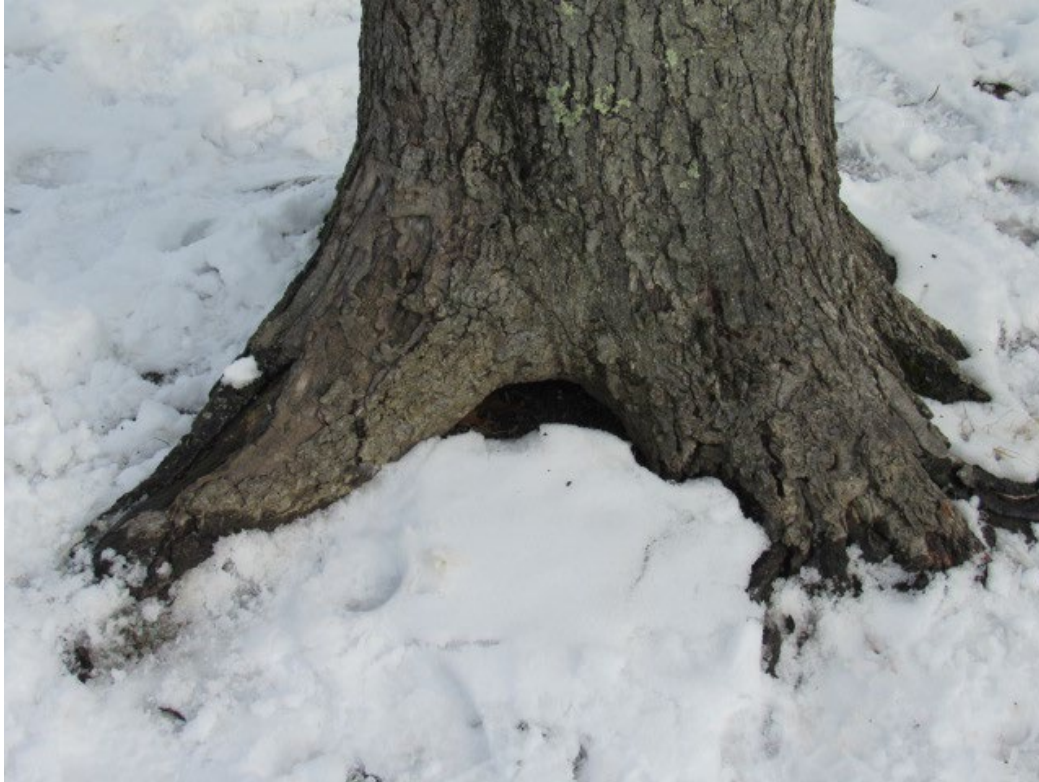
Photo 15, Red Maple with basal decay and buttress damage.

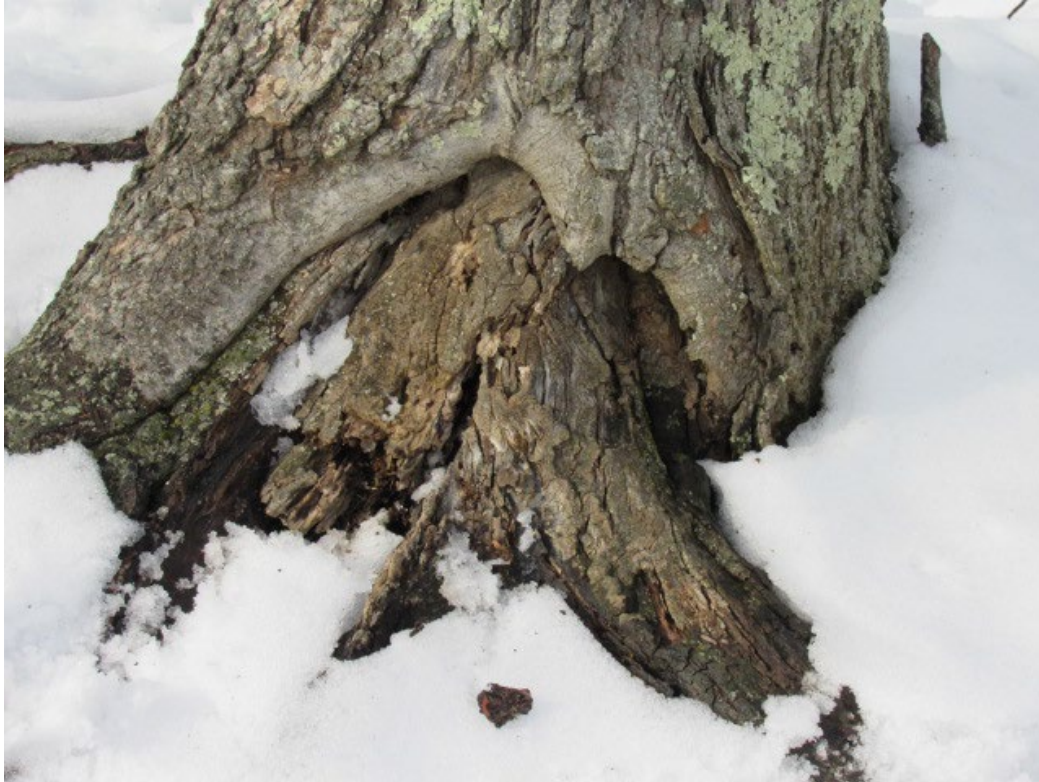
Photo 16, Red Maple with basal and buttress root decay. Removal recommended.

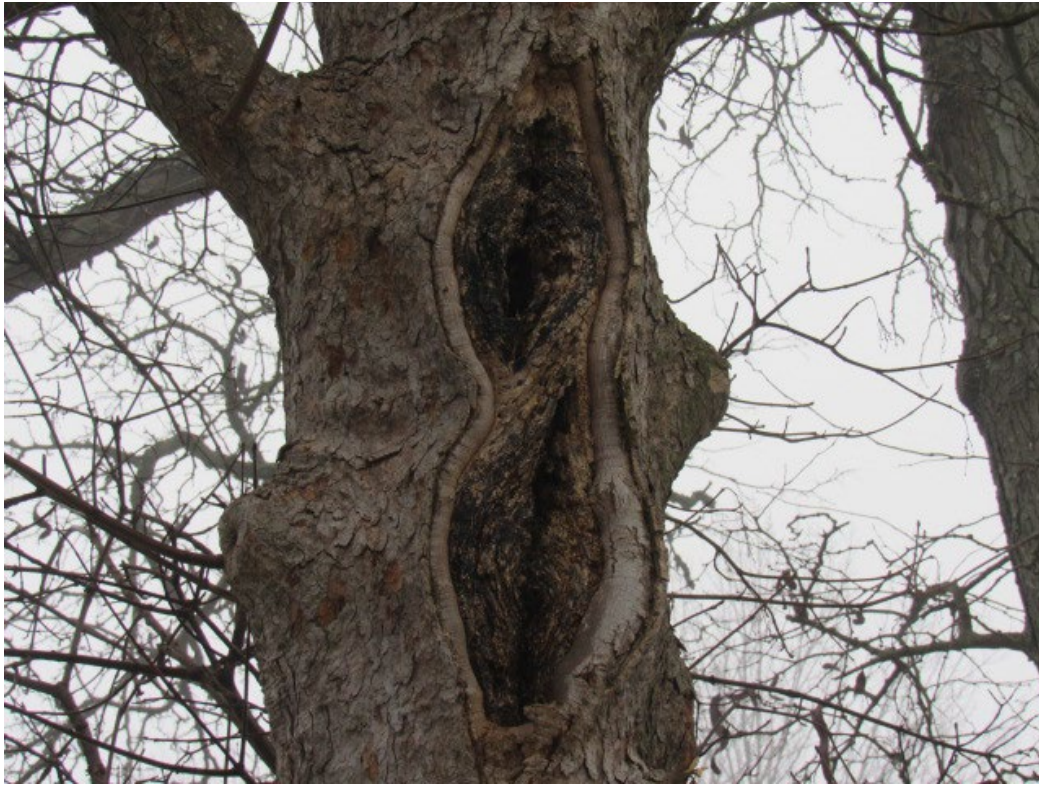
Photo 17, Sycamore Maple with stem decay. Removal recommended.

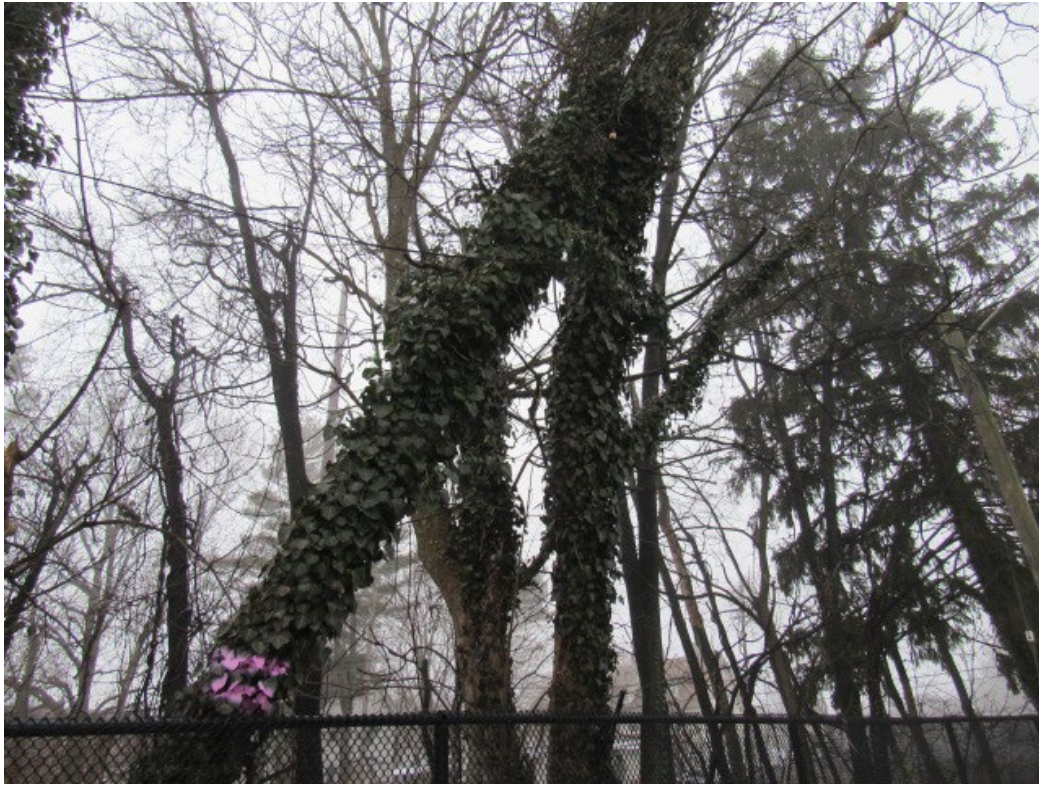
Photo 18, Leaning, uprooted Ash enveloped in ivy. Removal recommended.

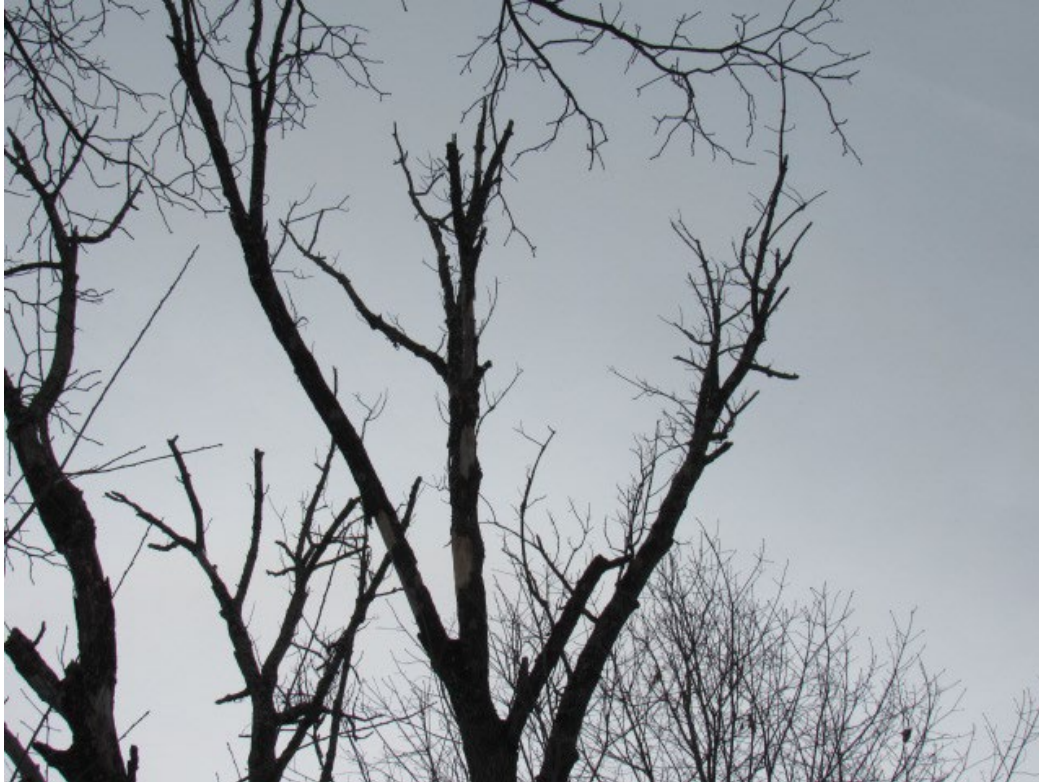
Photo 19, Ash trees killed by Emerald Ash Borer infestation. Removal recommended.

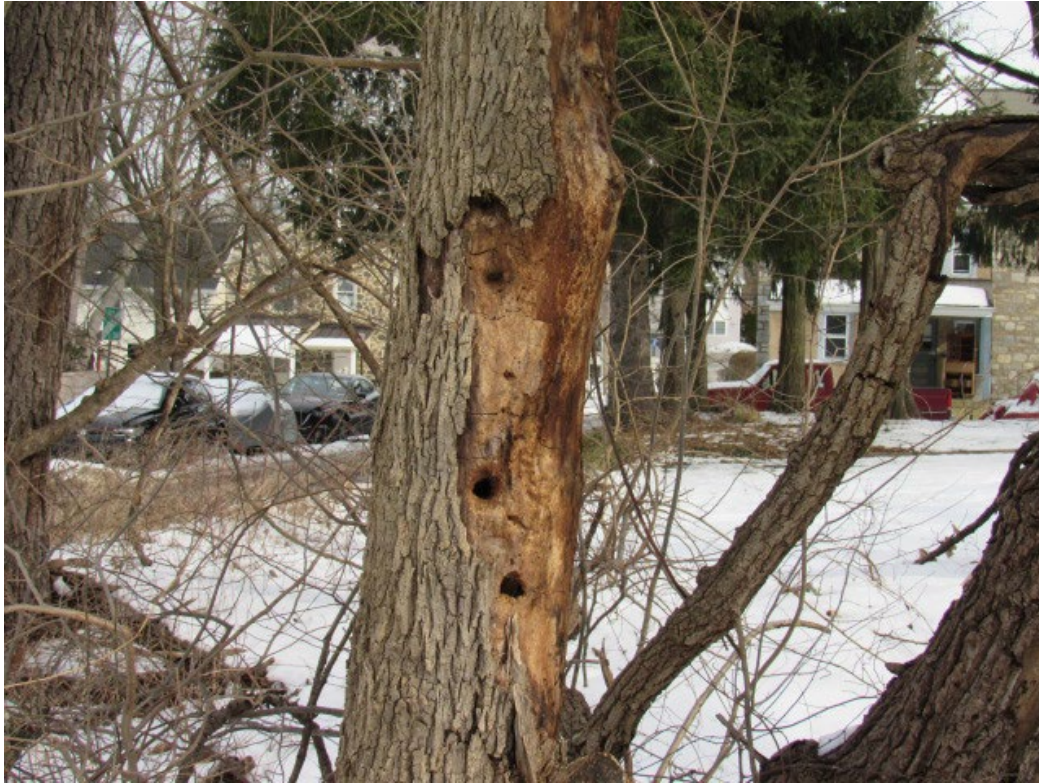
Photo 20, Deteriorated Ash. Removal recommended.

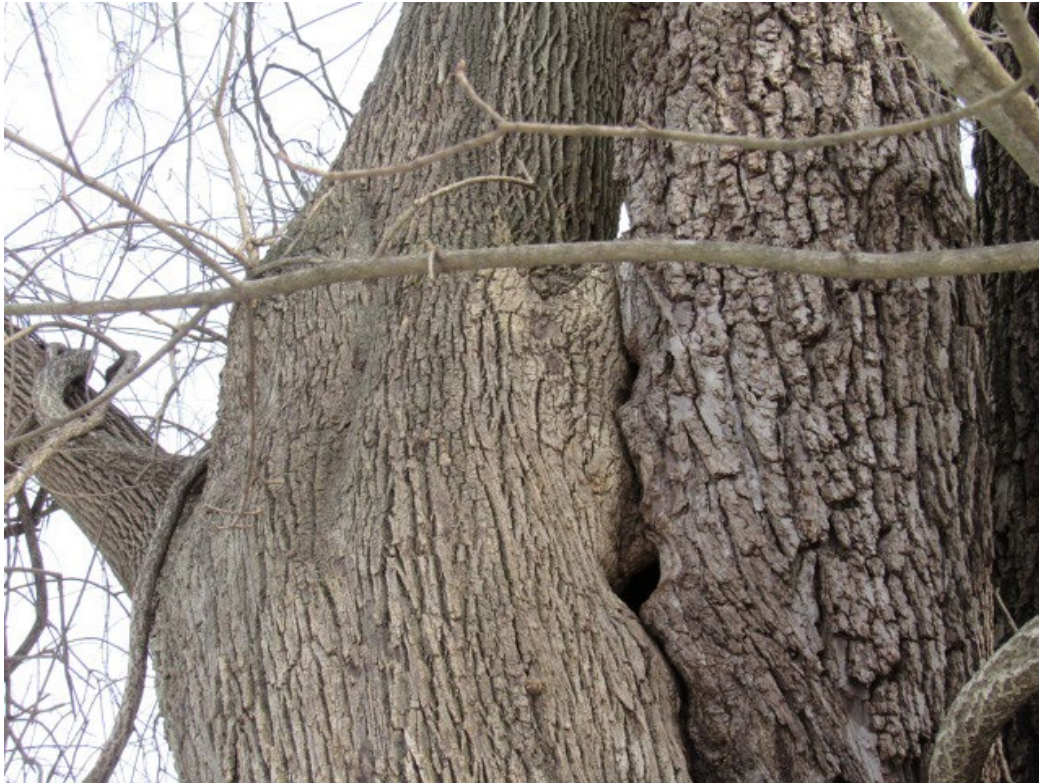
Photo 21, Black Walnut (43 in DBH) and White Ash (35 in DBH) growing together, both trees have stem decay, Ash also has severe decline. Removal is recommended for both trees. These trees are located at the side entrance drive at Odorisio Park.

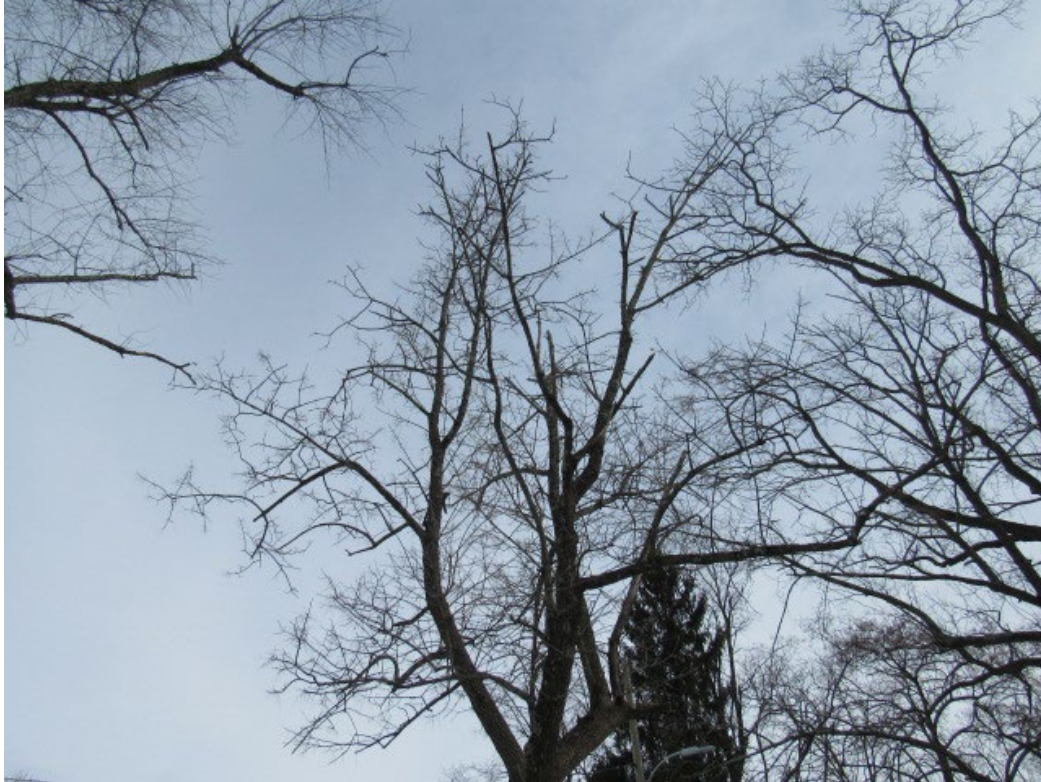
Photo 22, Ash in severe decline due to Emerald Ash Borers. Removal recommended.

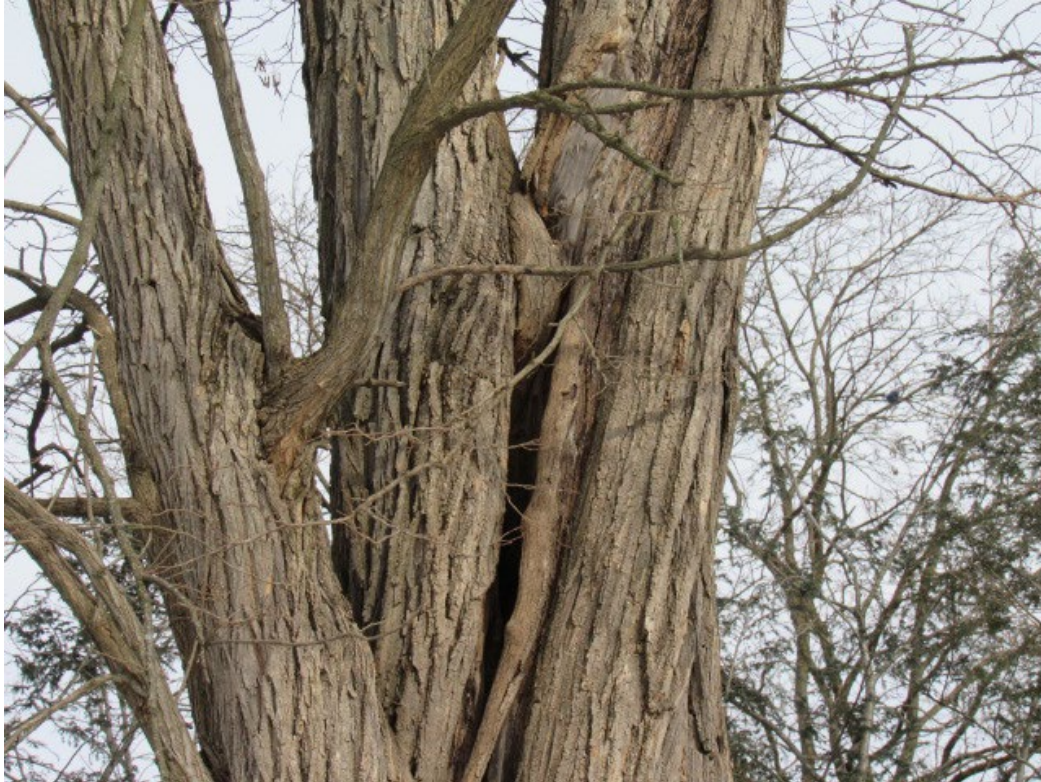
Photo 23, Bifurcated Black Locust with stem decay. Removal recommended.

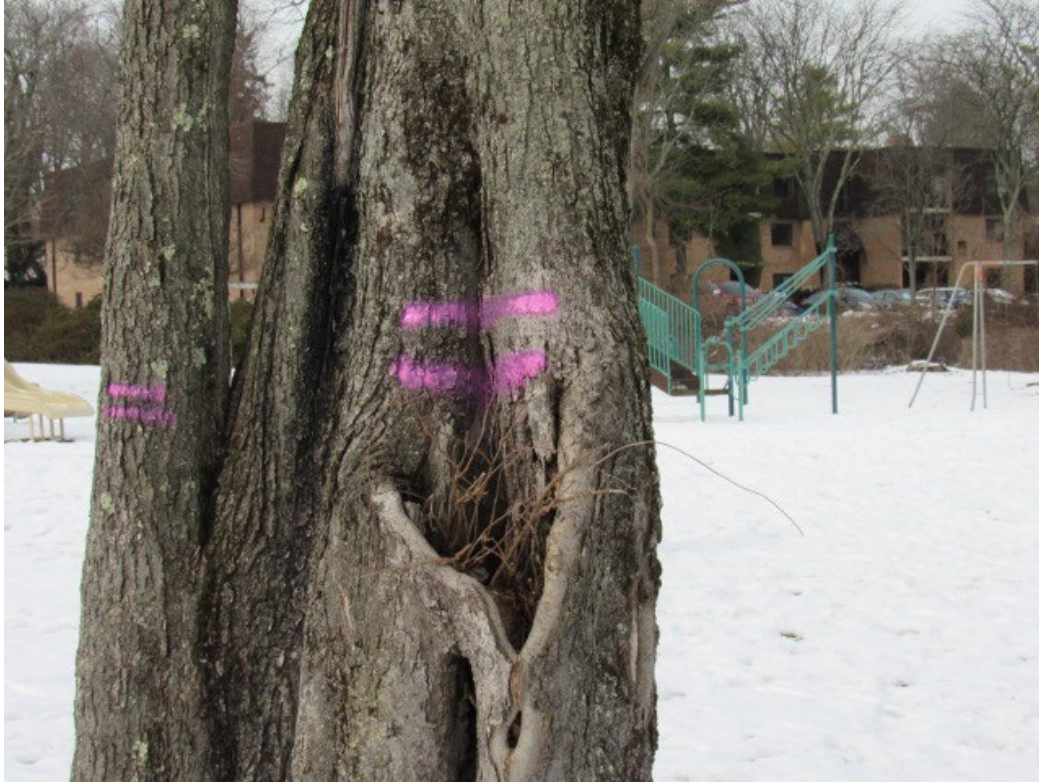
Photo 24, Red Maple with lower stem decay. Removal recommended.

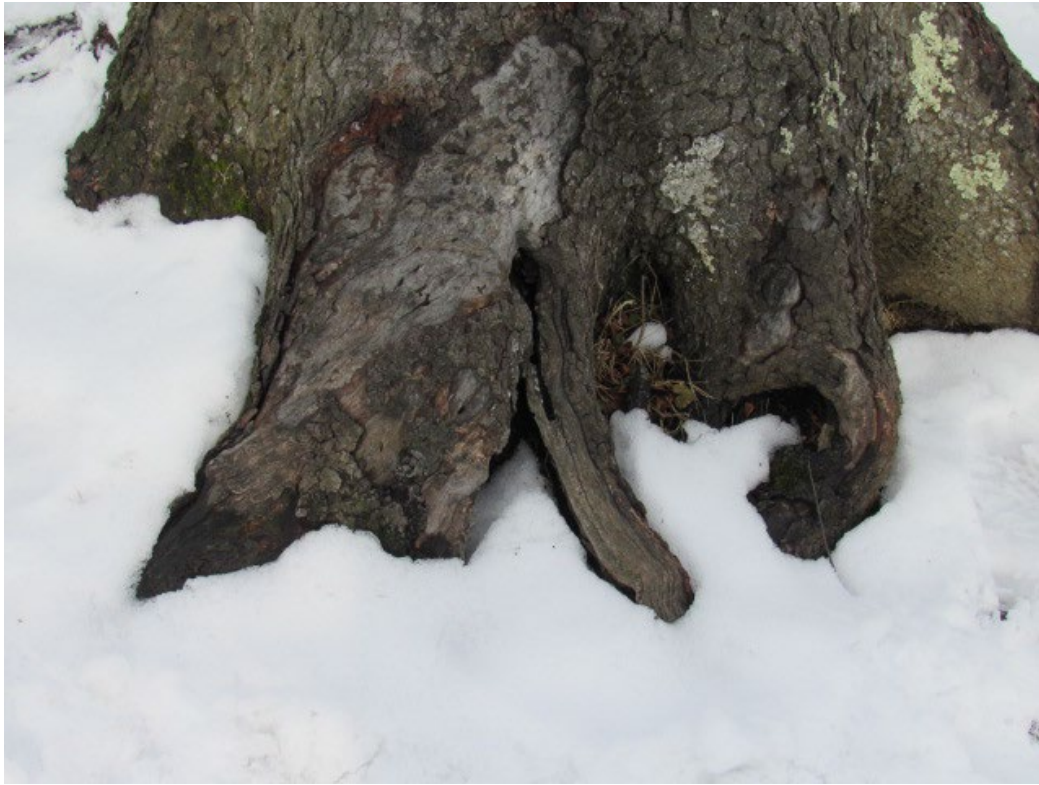
Photo 25, Wild Cherry wit buttress root decay. Removal recommended.

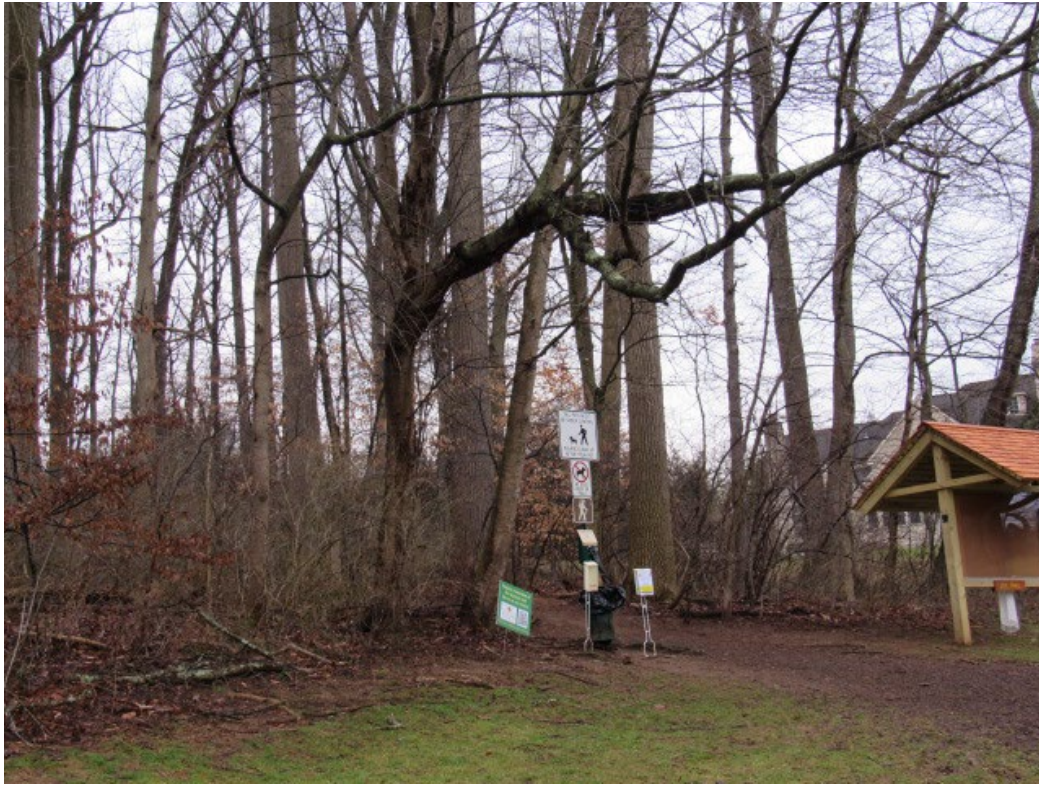
Photo 25, Large Wild Cherry with excessive lean. Removal recommended.

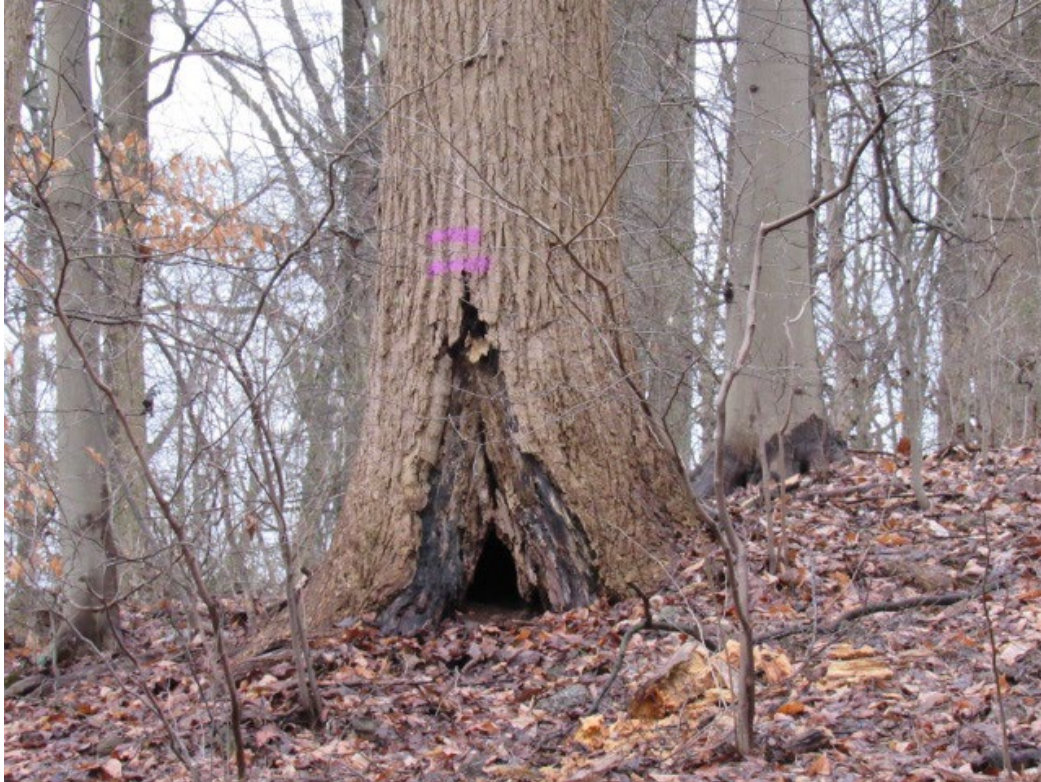
Photo 26, Mature Tulip Poplar with lower stem decay. Removal recommended.
