ROCKWELL ASSOCIATES

Radnor Parks

Re: Level One Park Review

File#: 8373RP

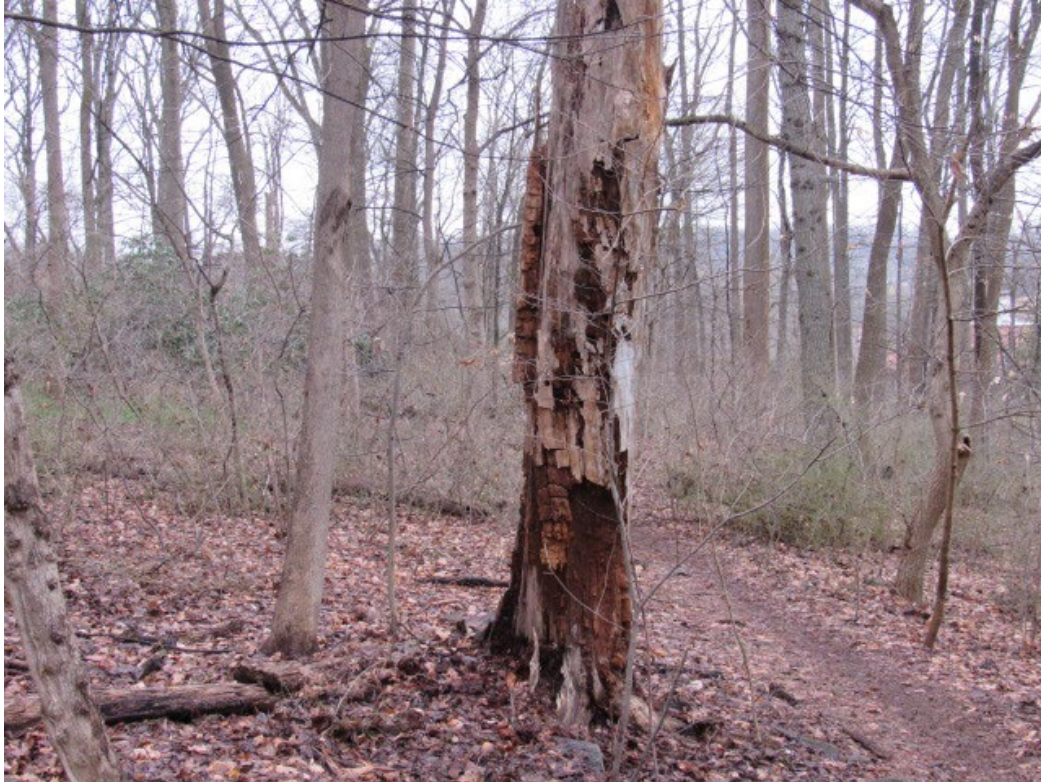
Photo 27, Deteriorated, dead tree adjacent trail in Ithan Valley Park. Removal recommended.

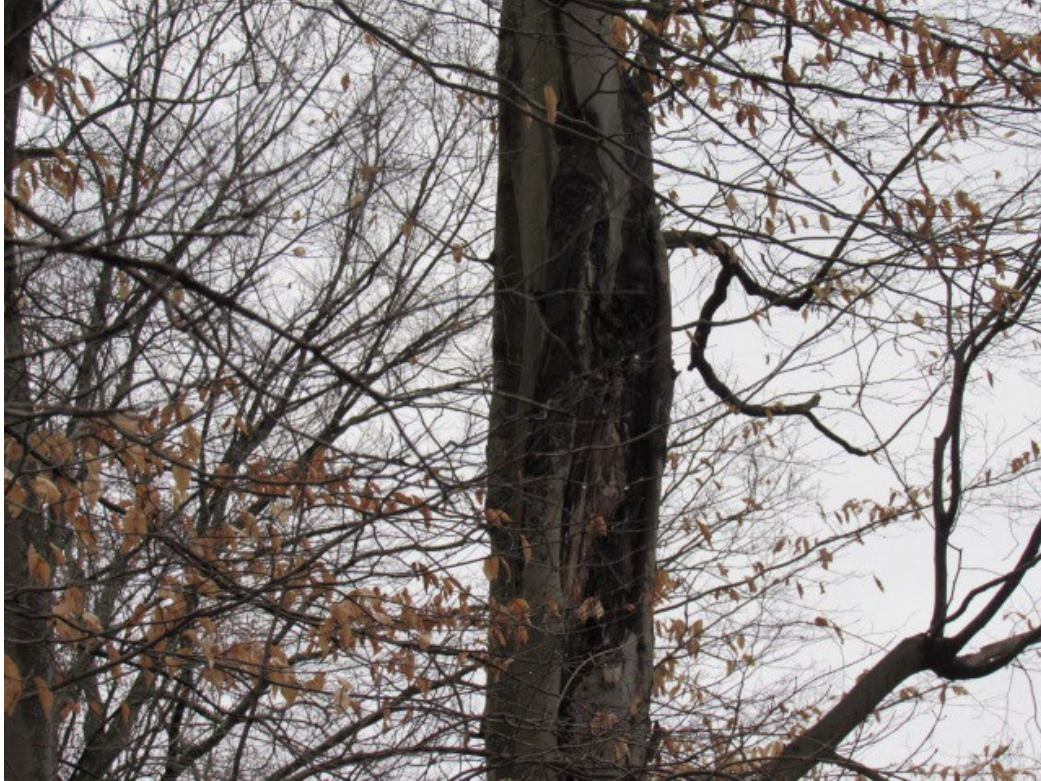
Photo 28, Mature American Beech with upper-stem decay. Removal recommended.

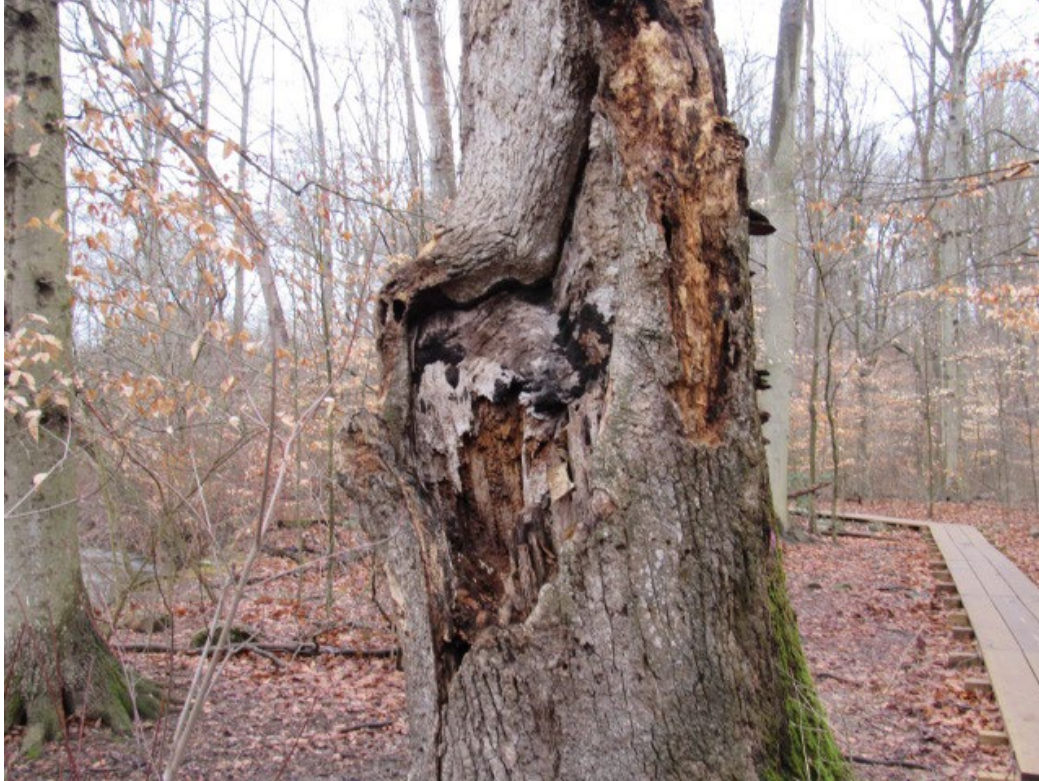
Photo 29, Red Maple with lower stem decay. Removal recommended.

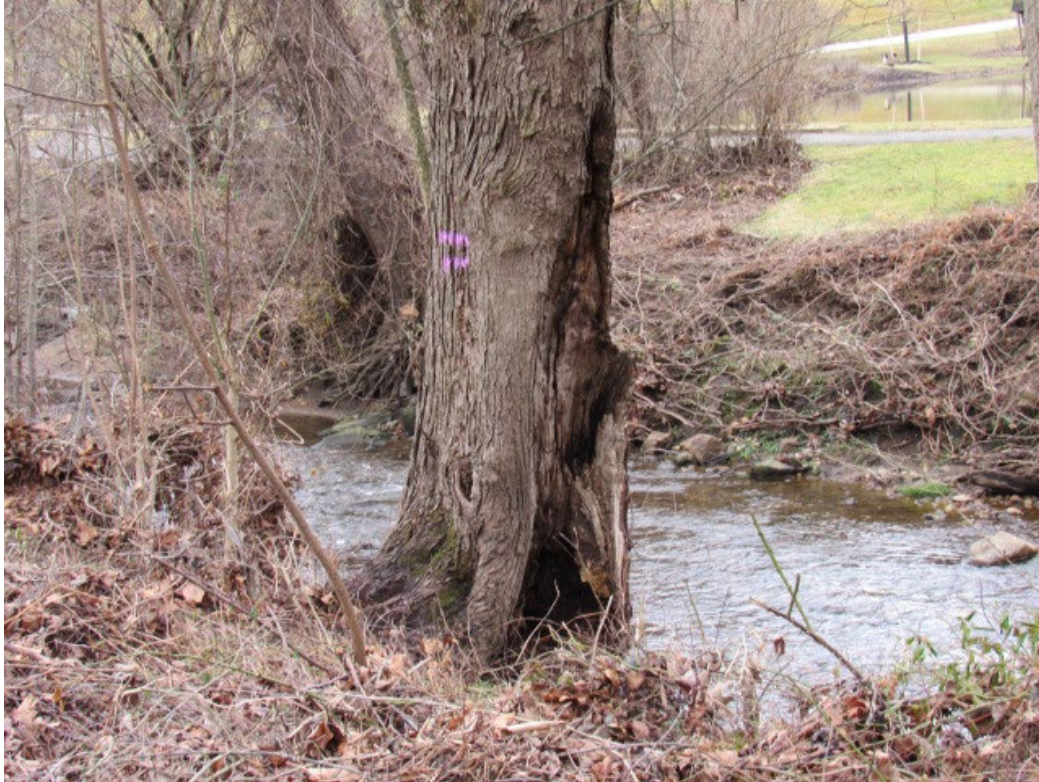
Photo 30, Mature Red Maple with lower stem decay adjacent stream, fishing spot. Removal recommended.
