## GANNETT FLEMING MEMORANDUM

**Date:** January 27, 2016

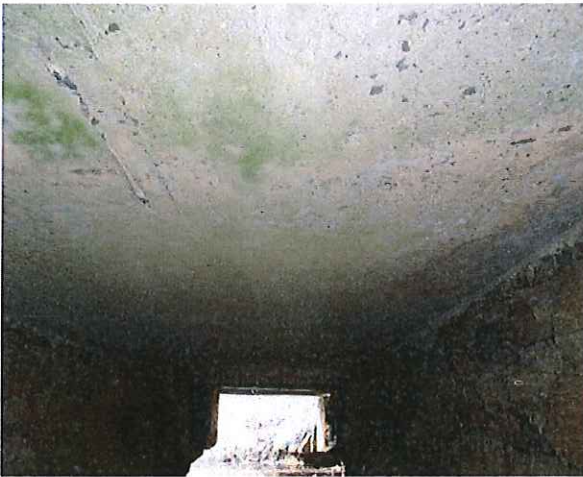
*View of Original Concrete Slab Superstructure (underside)*

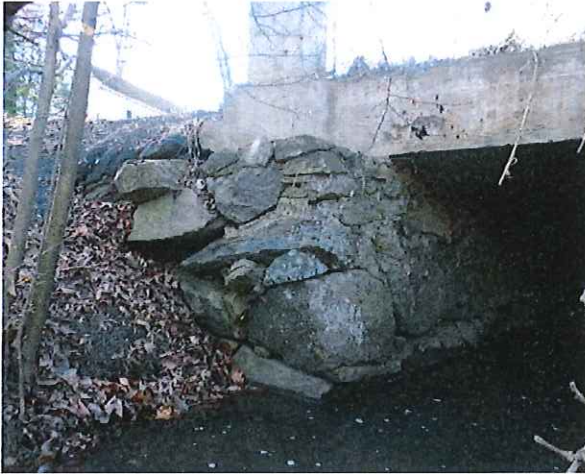
*East End of South Stone Masonry Abutment,  
Note Large Stones with Missing Mortar Joints*

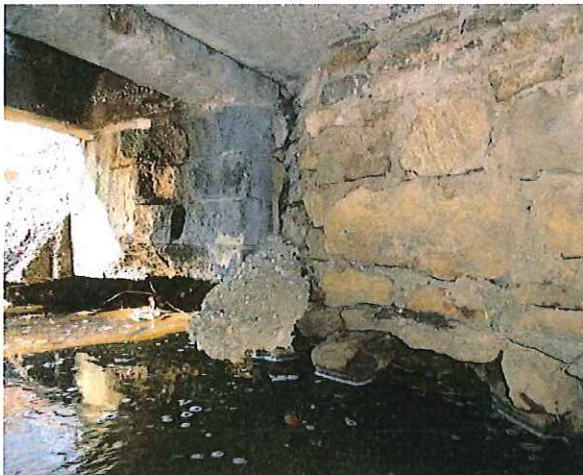
*North Abutment of Inlet Structure – Looking  
Northwest*
